CONDITION REPORT

Report No:
2017317864
DATE
27/10/2026

Vehicle Type	PASSENGER VEHICLE	Registered Owner	MFC
Manufacturer	NISSAN	Registration Number	JV72CMGP
Model	NP200 1.6 BASE SAFETY PU [2019-2025]	Register Number	
VIN	ADNUSN1D5U0187233	Date Of First Licensing	
Engine Number		Last COR	
Doors	4	License Expiry Date	
Color	WHITE	Power / Displacement	
Year Model	2021	Paint Finish	TWO COAT UNI
Km Reading	151,588 KM	Fuel	PETROL
Cab / Body Type	SINGLE CAB	Transmission	MANUAL

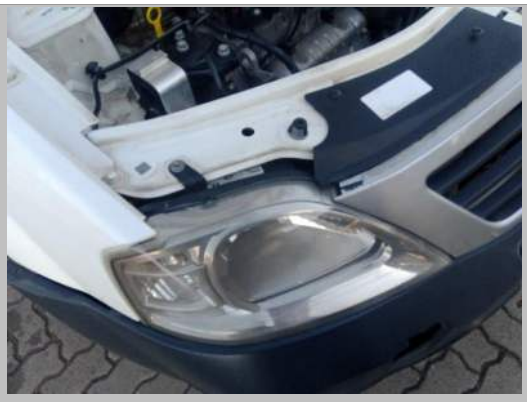
Damage	Repair Way
Fan Damaged	Repair
Water level Insufficient	Repair
Center Console / Cubbyhole + Lid Damaged	Replace
Tail Light Left Damaged	Replace
Tail Light Right Damaged	Replace
Headlight Left Damaged	Replace
Headlight Right Damaged	Replace
Seat Front Right Damaged	Replace
Front Bumper Damaged	Repair
Bonnet Damaged	Repair
Front Fender Left Damaged	Repair
Front Fender Right Damaged	Repair
Rear Fender Left Damaged	Repair
Rear Fender Right Damaged	Repair
Door Front Left Damaged	Repair
Door Front Right Damaged	Repair
Tailgate Damaged	Repair
Rear bumper Damaged	Repair
Roof Damaged	Repair
Windscreen Damaged	Replace
Service Brake Performance Rear Axle Left / Right Difference out of legal range	Repair
Parking Brake Performance Left / Right Difference out of legal range	Repair
Tyre Front Left Worn	Replace
Tyre Front Right Worn	Repair
Tyre Rear Left Worn	Replace
Tyre Rear Right Worn	Replace
Spare Tyre Worn	Replace
Bolt(s) / Nut(s) Front Wheel Right Damaged	Replace

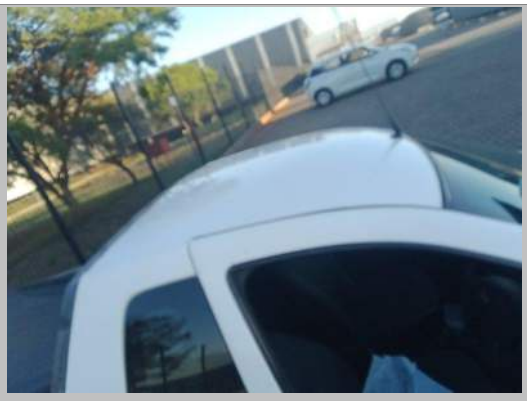
Rear Fender Right

General Comments: ACCORDING TO THE AGE AND MILEAGE OF THE VEHICLE, NORMAL WEAR AND TEAR MARKS ARE VISIBLE ON THE INTERIOR, EXTERIOR, ELECTRICAL AND MECHANICAL PARTS. LICENSE DISC MISSING.Engine Compartment: Foreign substance on oil filler cap.
Body • Exterior: Minor dents and scratches and stone chips to body panels. Signs of repair work done to body panels. Poor alignment to somebody panels. Vehicle body in poor condition. Repair work done to vehicle below standard. Tony cover damage
