CONDITION REPORT

Report No:
2017308480
DATE
07/10/2026

Vehicle Type	LIGHT LOAD VEHICLE	Registered Owner	MFC
Manufacturer	NISSAN	Registration Number	MC78PMGP
Model	NP200 1.6 8V BASE +AC SAFETY PU [2011-2025]	Register Number	
		Date Of First Licensing	
VIN	ADNUSN1D5U0194687	Last COR	
Engine Number		License Expiry Date	
Doors	2	Power / Displacement	
Color	WHITE	Paint Finish	TWO COAT UNI
Year Model	2021	Fuel	PETROL
Km Reading	143,661 KM	Transmission	MANUAL
Cab / Body Type	SINGLE CAB

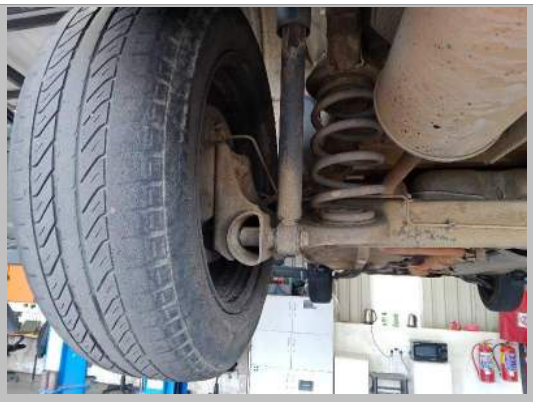
LF TYRE TREAD

Size	Load/Speed Index	Manufacture	Model	Type*	Production Date	Tread Depth (mm)
Front Left	185/65R15	92T	Dunlop	Sp-Touring	V	4223	1 mm
Front Right	185/65R15	92T	Dunlop	Sp-Touring	V	4423	1 mm
Rear Left	185/65R15	92H	Dunlop	Sp-Sport	V	4822	0 mm
Rear Right	185/65R15	88H	Tranzano	Radial	V	5123	4 mm
Spare	185/65R15	88H	Firestone	Touring	V	0320	0 mm
