CONDITION REPORT

Report No:
2017316486
DATE
23/10/2026

MFC Auction House
M57 Pretoria Rd, Glenmarais, KEMPTON PARK
Gauteng

Vehicle Type	LIGHT LOAD VEHICLE	Registered Owner	MFC AUCTION HOUSE
Manufacturer	NISSAN	Registration Number	KT64LTGP
Model	NP200 1.6 8V BASE +AC SAFETY PU [2011-2025]	Register Number	
		Date Of First Licensing	
VIN	ADNUSN1D5U0210214	Last COR	
Engine Number		License Expiry Date	30/09/2026
Doors	2	Power / Displacement	
Color	WHITE	Paint Finish	TWO COAT UNI
Year Model	2022	Fuel	PETROL
Km Reading	149,393 KM	Transmission	MANUAL
Cab / Body Type	SINGLE CAB

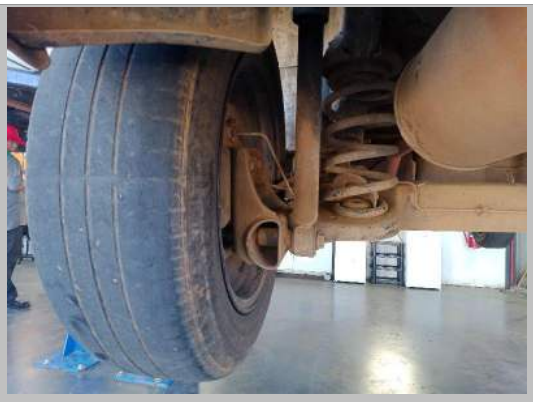
LF TYRE TREAD

Size	Load/Speed Index	Manufacture	Model	Type*	Production Date	Tread Depth (mm)
Front Left	195/60 R15	88H	Annaite	AN600	V	0524	3 mm
Front Right	195/60 R15	88H	Annaite	AN600	V	0524	0 mm
Rear Left	185/65 R15	88H	Bridgestone	B250	V	4016	0 mm
Rear Right	185/65 R15	92T	Dunlop	Sp-Sport	V	0322	0 mm

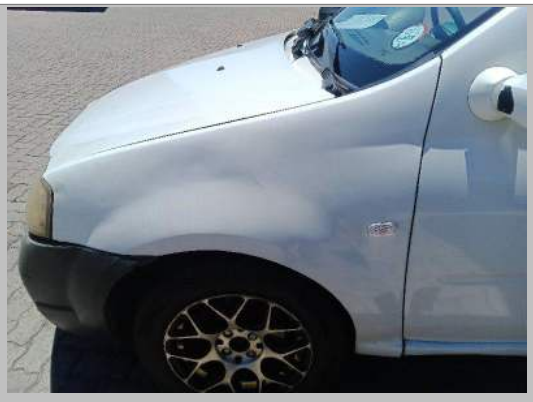
Front Fender Right / Inner Tray Damaged	Replace
Door Front Left Damaged	Repair
Door Front Right Damaged	Repair
Tailgate Damaged	Repair
Rear bumper Paintwork • Scratched	Repair
Sill Panel Left Damaged	Repair
Sill Panel Right Damaged	Repair
Roof Residual Traces of Repair	Repair
Load Body Damaged	Repair
Windscreen Cracked	Replace
Speed Sensor Damaged	Replace
Parking Brake Performance Left / Right Difference out of legal range	Repair
Steering Rack Boot Left Damaged	Replace
Steering Rack Boot Right Leak	Replace
Shock Absorber Front Right Sweat	Replace
Wheel bearing Front Left Loose / Excessive Play	Replace
Rear Axle Damaged	Repair
Ball Joint(s) Front Axle Right Loose / Excessive Play	Repair
Mounting Rubber(s) Rear Axle Left Cracked	Replace
Mounting Rubber(s) Rear Axle Right Cracked	Replace
Tyre Front Left Damaged	Replace
Tyre Front Right Damaged	Replace
Tyre Rear Left Damaged	Replace
Tyre Rear Right Damaged	Replace
Rim Front Left Scratched	Repair

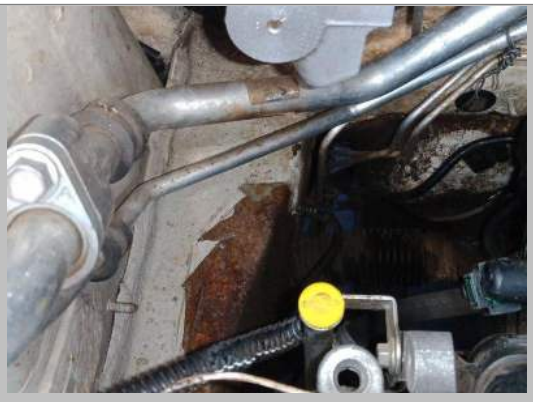
Damage	Repair Way
Engine Oil Leak	Repair
Engine Wiring Defective	Repair
Air cleaner Damaged	Replace
Central Air Vent Damaged	Replace
Radio/CD/USB Missing	Replace
Air Conditioner Insufficient	Replace
Tail Light Left Cracked	Replace
Tail Light Right Damaged	Replace
Headlight Left Damaged	Replace
Headlight Right Damaged	Replace
Seat Front Left Damaged	Repair
Seat Front Right Damaged	Repair
Sun Visor Right Damaged	Repair
Hood Lining Dirty	Repair
Door Lock Front Left Damaged	Replace
Carpet Front Damaged	Repair
Mirror Adjusters Damaged	Replace
Steering Wheel Trim Excessive Wear & Tear	Repair
Side Mirror Left Paintwork • Scratched	Repair
Side Mirror Right Paintwork • Scratched	Repair
Front Bumper Damaged	Repair
Grill Paintwork • Scratched	Repair
Bonnet Damaged	Replace
Front Fender Left Damaged	Repair
Front Fender Right Damaged	Repair
Rear Fender Left Damaged	Repair
Rear Fender Right Damaged	Repair
Front Fender Left / Inner Tray Damaged	Repair

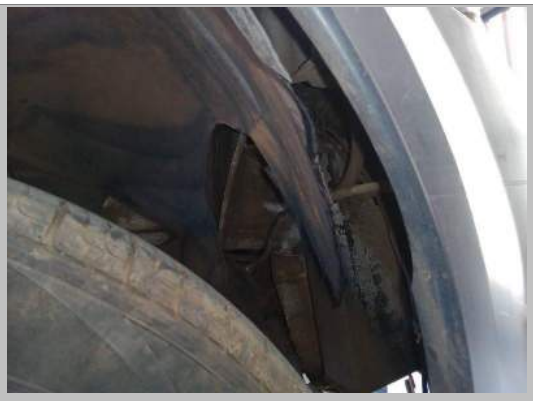
Damage	Repair Way
Rim Rear Right Scratched	Repair
Bolt(s) / Nut(s) Front Wheel Right Missing	Replace
Bolt(s) / Nut(s) Rear Wheel Left Missing	Replace
Main Beam Left Dented	Repair
Main Beam Right Damaged	Repair
Chassis Damaged	Repair
Belly plates Damaged	Repair
Gearbox Oil Leak	Repair
Fuel Tank Damaged	Repair
CV Joint(s) Boot(s) Front Left (inner/outer) Damaged	Replace
Radiator Cradle Damaged	Repair
Engine Noise Excessive	Repair
Triangle Missing	Replace
Right quarter window damaged	Replace
Bonnet release handle damaged	Replace
ABS warning light illuminated on dashboard	Repair
Front bumper stiffener damaged	Replace
Aircon condenser dented	Repair
Front left brake caliper dust plate loose	Replace
Spare wheel missing	Replace
Dipstick holder damaged	Replace
Front and rear tyre sizes different	Repair
