CONDITION REPORT

Report No:
2017314654
DATE
21/10/2026

Vehicle Type	LIGHT LOAD VEHICLE	Registered Owner	
Manufacturer	FORD	Registration Number	HHZ184L
Model	RANGER	Register Number	
VIN	AFAGXXMJ2GCT80215	Date Of First Licensing	
Engine Number		Last COR	
Doors	4	License Expiry Date	31/12/2026
Color	WHITE	Power / Displacement	
Year Model		Paint Finish	TWO COAT UNI
Km Reading	193,735 KM	Fuel	DIESEL
Cab / Body Type	SUPER CAB	Transmission	AUTOMATIC

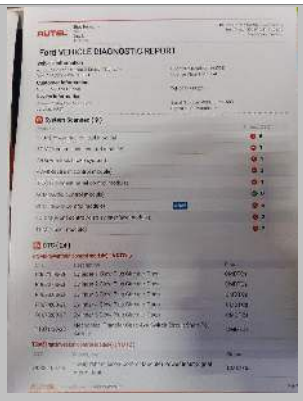
Diagnostic Report page 1

No	System	Code	Description	Status
1	PCM	P0671:00-2F	CYLINDER ONE GLOW PLUG CIRCUIT OPEN

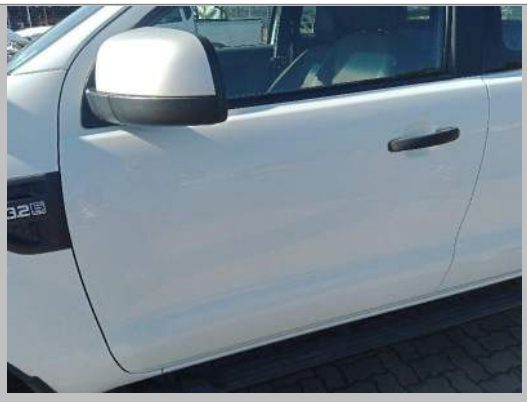
Damage	Repair Way
Engine Oil Leak	Repair
Central Air Vent Damaged	Replace
Switch Electrical Window Winder front left Damaged	Repair
Switch Electrical Window Winder front right Damaged	Replace
Seat Front Right Damaged	Replace
Door Handle Rear Left Damaged	Replace
Door Handle Rear Right Damaged	Replace
Front Bumper Damaged	Repair
Bonnet Damaged	Repair
Front Fender Left Damaged	Repair
Front Fender Right Damaged	Repair
Rear Fender Left Damaged	Repair
Rear Fender Right Damaged	Repair
Door Front Left Damaged	Repair
Door Front Right Damaged	Repair
Door Rear Left Damaged	Repair
Door Rear Right Damaged	Repair
Tailgate Damaged	Repair
Rear bumper Damaged	Repair
Tyre Front Left Worn	Replace
Tyre Front Right Worn	Replace
Tyre Rear Right Damaged	Replace
Spare Tyre Worn	Replace
Gearbox Oil Leak	Repair
Both front electric windows do not open.	Repair
