CONDITION REPORT

Report No:
2017307847
DATE
08/10/2026

Vehicle Type	LIGHT LOAD VEHICLE	Registered Owner	MFC
Manufacturer	FORD	Registration Number	JR17TGGP
Model	RANGER 2.2 TDCI XLS 4X4 DSL PU AT [2020-2021]	Register Number	
		Date Of First Licensing	
VIN	AFANXXMJ2NKT42214	Last COR	
Engine Number		License Expiry Date	
Doors	2	Power / Displacement	
Color	WHITE	Paint Finish	C - COMMON
Year Model	2020	Fuel	DIESEL
Km Reading	243,840 KM	Transmission	AUTOMATIC
Cab / Body Type	SINGLE CAB

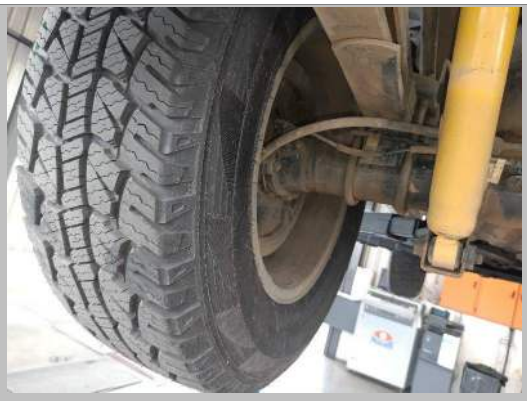
LR TYRE TREAD

Size	Load/Speed Index	Manufacture	Model	Type*	Production Date	Tread Depth (mm)
Front Left	265/65R17	112S	Bridgestone	Dueler	V	2423	5 mm
Front Right	265/65R17	112S	Bridgestone	Dueler	V	2423	3 mm
Rear Left	265/65R17	112T	Annaite	AN906	V	0626	9 mm
Rear Right	265/65R17	112S	Bridgestone	Dueler	V	3522	2 mm

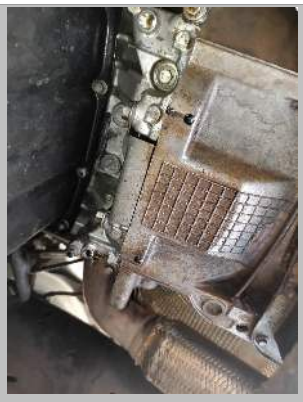
Damage	Repair Way
Seat Front Right Torn / Cut	Repair
Front Fender Left Paintwork • Scratched	Repair
Door Front Left Residual Traces of Repair	Repair
Load Body Paintwork • Scratched	Repair
Gearbox Oil Leak	Repair
Differential Oil Leak	Repair
Engine Performance Insufficient	Repair
4x4 Differential Lock Insufficient	Repair
Low and High Range Selection Insufficient	Repair
Body exterior	Residual traces of repair work on body panels
Body exterior	Minor dents scratches stone chips on body panels
Body exterior	Signs of spray work done on body panels
Engine	Bottom of engine is fully covered
Warning lights illuminated	Repair
