CONDITION REPORT

Report No:
2017309255
DATE
09/10/2026

Vehicle Type	LIGHT LOAD VEHICLE	Registered Owner	MFC
Manufacturer	FORD	Registration Number	LW31ZYGP
Model	RANGER 2.0 BIT WILDTRAK DSL D-CAB PU 10-SP AT [2020-2021]	Register Number	
		Date Of First Licensing	
VIN	AFAPXXMJ2PLR82260	Last COR	
Engine Number		License Expiry Date	
Doors	4	Power / Displacement	
Color	WHITE	Paint Finish	TWO COAT UNI
Year Model	2020	Fuel	DIESEL
Km Reading	94,006 KM	Transmission	AUTOMATIC
Cab / Body Type	DOUBLE CAB

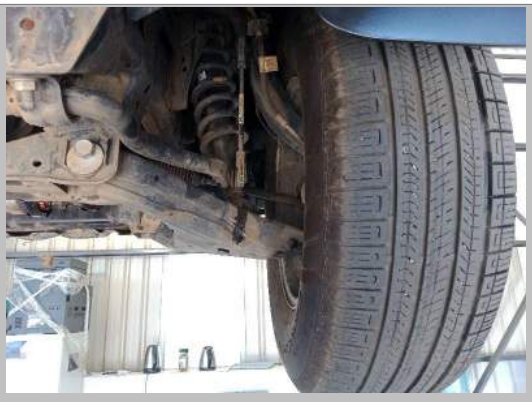
LF TYRE TREAD

LR TYRE TREAD

RR TYRE TREAD

RF TYRE TREAD
