CONDITION REPORT

Report No:
2017318911
DATE
29/10/2026

Vehicle Type	LIGHT LOAD VEHICLE	Registered Owner	MFC AUCTION HOUSE
Manufacturer	FORD	Registration Number	LGG614NW
Model	RANGER 2.2 TDCI XL 4X4 DSL D-CAB PU AT [2020-2021]	Register Number	
		Date Of First Licensing	
VIN	AFAPXXMJ2PLT55247	Last COR	
Engine Number		License Expiry Date	31/05/2026
Doors	4	Power / Displacement	
Color	WHITE	Paint Finish	TWO COAT UNI
Year Model	2021	Fuel	DIESEL
Km Reading	203,015 KM	Transmission	AUTOMATIC
Cab / Body Type	DOUBLE CAB

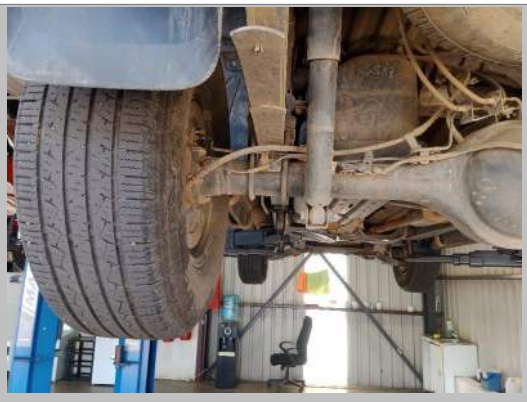
RF TYRE TREAD

Size	Load/Speed Index	Manufacture	Model	Type*	Production Date	Tread Depth (mm)
Front Left	255/70R16	111H	Annaite	Radial	V	0124	3 mm
Front Right	255/70R16	111H	Annaite	Radial	V	0124	3 mm
Rear Left	2550l/70R16	111H	Annaite	Radial	V	0124	3 mm
Rear Right	255/70R16	111H	Annaite	Radial	V	0124	3 mm
Spare	255/70R16	111T	Continental	Crosscontact	V	4420	3 mm

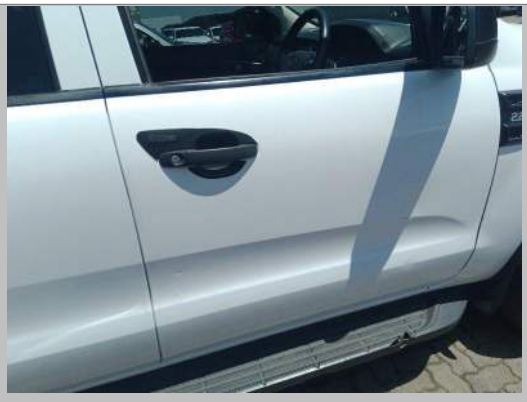
Damage	Repair Way
Under bonnet insulation cover Damaged	Repair
Air Conditioner Insufficient	Repair
Tail Light Left Damaged	Replace
Front Bumper Damaged	Repair
Bonnet Damaged	Repair
Front Fender Left Damaged	Repair
Front Fender Right Damaged	Repair
Rear Fender Left Damaged	Repair
Rear Fender Right Residual Traces of Repair	Repair
Door Front Left Damaged	Repair
Door Front Right Damaged	Repair
Door Rear Right Damaged	Repair
Rear bumper Damaged	Repair
Rocker Panel Right Damaged	Replace
Windscreen Damaged	Replace
Differential Oil Leak	Repair
