CONDITION REPORT

Report No:
2017310688
DATE
12/10/2026

Vehicle Type	LIGHT LOAD VEHICLE	Registered Owner	MFC
Manufacturer	FORD	Registration Number	MG42WBGP
Model	RANGER 3.0 V6 PLATINUM 4WD DSL D-CAB PU OPT PLAN 10-SP AT [2024-2026]	Register Number	
		Date Of First Licensing	
VIN	AFAPXXMJ2PRE41003	Last COR	
Engine Number		License Expiry Date	28/02/2027
Doors	4	Power / Displacement	
Color	WHITE	Paint Finish	C - COMMON
Year Model	2025	Fuel	DIESEL
Km Reading	78,629 KM	Transmission	AUTOMATIC
Cab / Body Type	DOUBLE CAB

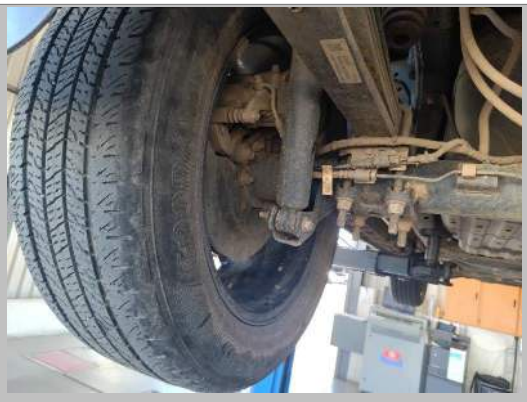
LR TYRE TREAD

Size	Load/Speed Index	Manufacture	Model	Type*	Production Date	Tread Depth (mm)
Front Left	255/50R20	109Y	Dimax	Radar		0924	5 mm
Front Right	255/50R20	109Y	Dimax	Radar	V	0924	2 mm
Rear Left	255/55R20	110V	Goodyear	Wrangler	V	0124	0 mm
Rear Right	255/55R20	110V	Goodyear	Wrangler	V	0124	3 mm
Spare	255/55R20	110V	Goodyear	Wrangler	V	0000	6 mm

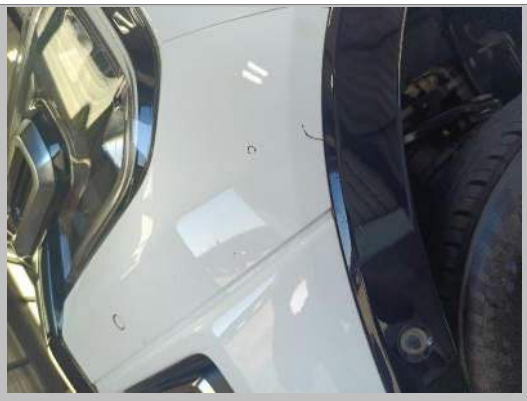
Damage	Repair Way
Front Bumper Paintwork • Scratched	Repair
Grill Damaged	Replace
Door Rear Left Paintwork • Scratched	Repair
Load Body Paintwork • Scratched	Repair
Windscreen Cracked	Replace
Tyre Rear Left Smooth	Replace
Rim Front Right Deformed	Repair
