CONDITION REPORT

Report No:
2017313077
DATE
16/10/2026

MFC Auction House
M57 Pretoria Rd, Glenmarais, KEMPTON PARK
Gauteng

Vehicle Type	LIGHT LOAD VEHICLE	Registered Owner	MFC
Manufacturer	FORD	Registration Number	HNS884L
Model	RANGER	Register Number	
VIN	AFAPXXMJ2PSA82857	Date Of First Licensing	
Engine Number		Last COR	
Doors	4	License Expiry Date	31/01/2027
Color	WHITE	Power / Displacement	
Year Model		Paint Finish	TWO COAT UNI
Km Reading	12,944 KM	Fuel	DIESEL
Cab / Body Type	DOUBLE CAB	Transmission	AUTOMATIC

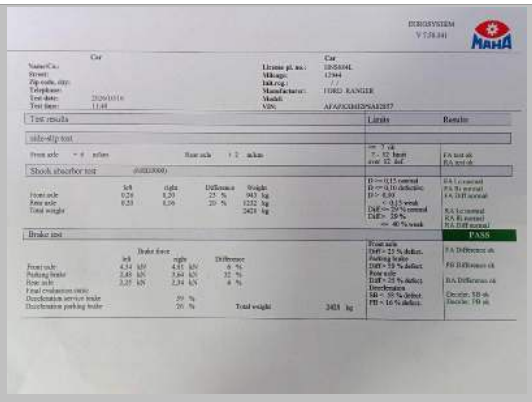
Brake and shock absorber repor

Left	Right		
	Braking Force [KN]	Braking Force [KN]	Axle Weight [KG]	Deceleration [m/s²]
Front	4.54	4.81	-	
Rear	2.25	2.34	-	
Emergency / Parking	2.48	3.64	-

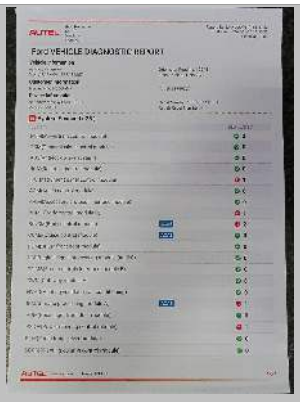
Diagnostic report page 1

No	System	Code	Description	Status
1	IPC(INSTRUMENT PANEL CONTROL MODULE)	U3003:16-08	BATTERY VOLTAGE
