# CONDITION REPORT

**Report No:**
**2017316339**
**DATE**
**23/10/2026**

*MFC Auction House*
*M57 Pretoria Rd, Glenmarais, KEMPTON PARK*
*Gauteng*

| Manufacturer | BAIC | Registration Number | LCT034MP |

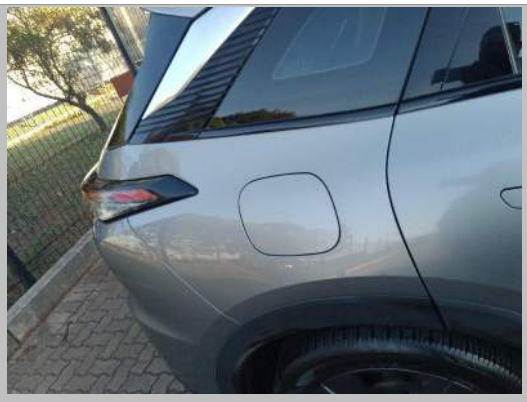
| Damage | Repair Way |
|---|---|
| Rear Fender Right Damaged | Repair |
