CONDITION REPORT

Report No:
2017316644
DATE
23/10/2026

Vehicle Type	LIGHT LOAD VEHICLE	Registered Owner	
Manufacturer	TOYOTA	Registration Number	HMF849L
Model	HILUX 2.8 GD-6 RB LEGEND DSL X-CAB PU AT [2024-2025]	Register Number	
		Date Of First Licensing	
VIN	AHTAA3DC701714857	Last COR	
Engine Number		License Expiry Date	
Doors	4	Power / Displacement	
Color	WHITE	Paint Finish	TWO COAT UNI
Year Model	2025	Fuel	DIESEL
Km Reading	53,245 KM	Transmission	AUTOMATIC
Cab / Body Type	SUPER CAB

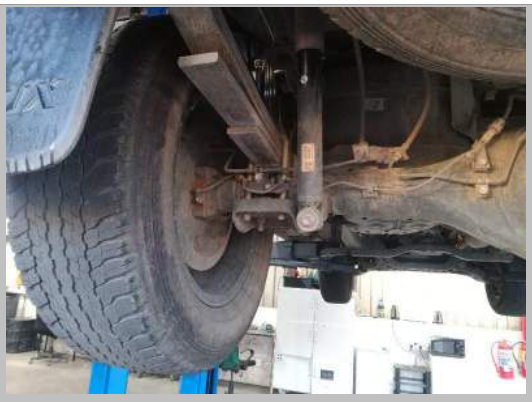
LF TYRE TREAD

Size	Load/Speed Index	Manufacture	Model	Type*	Production Date	Tread Depth (mm)
Front Left	265/60 R18	110H	Dunlop	Grandtrek	V	1925	3 mm
Front Right	265/60 R18	110H	Dunlop	Grandtrek	V	1925	3 mm
Rear Left	265/60 R18	110H	Dunlop	Grandtrek	V	1925	5 mm
Rear Right	265/60 R18	110H	Dunlop	Grandtrek	V	1925	5 mm
Spare	265/60 R18	110H	Dunlop	Grandtrek	V	0000	8 mm
