CONDITION REPORT

Report No:
2017304579
DATE
30/09/2026

Vehicle Type	LIGHT LOAD VEHICLE	Registered Owner	MFC
Manufacturer	TOYOTA	Registration Number	HHP856L
Model	HILUX 2.8 GD-6 RB LEGEND RS DSL D-CAB PU AT [2023-2024]	Register Number	
		Date Of First Licensing	
VIN	AHTAA3DD501735232	Last COR	
Engine Number		License Expiry Date	30/11/2026
Doors	4	Power / Displacement	
Color	WHITE	Paint Finish	PEARL EFFECT
Year Model	2024	Fuel	DIESEL
Km Reading	37,952 KM	Transmission	AUTOMATIC
Cab / Body Type	DOUBLE CAB

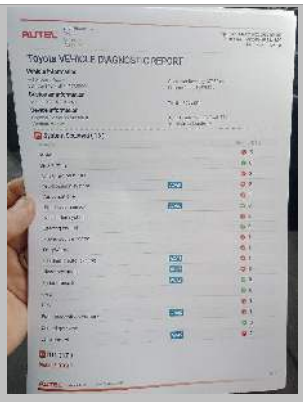
Diagnostic report

No	System	Code	Description	Status
1	BRAKE	C137BA2	BRAKE SYSTEM CONTROL MODULE A SYSTEM VOLTAGE SYSTEM VOLTAGE LOW	CONFIRMED

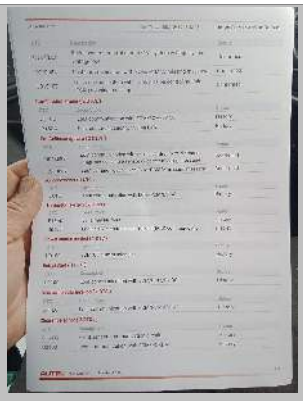
During the diagnostic the following error messages were detected: (See also attached Diagnostic Report. For more information regarding the Fault Codes (DTC) and the recommended rectifications please contact the workshops of the vehicle manufacture).

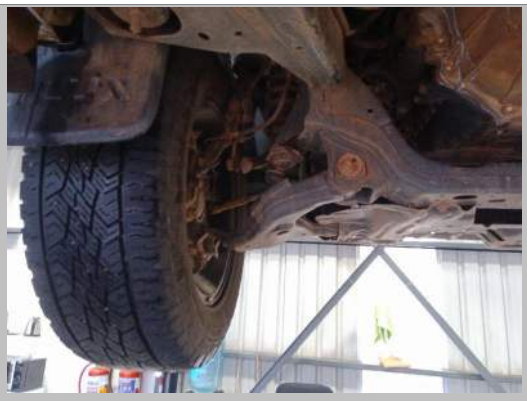
LF TYRE TREAD

Size	Load/Speed Index	Manufacture	Model	Type*	Production Date	Tread Depth (mm)
Front Left	265/60R18	110H	Continental	Crosscontact	V	2023	2 mm
Front Right	265/60R18	110H	Continental	Crosscontact	V	2023	2 mm
Rear Left	265/60R18	110H	Continental	Crosscontact	V	2023	3 mm
Rear Right	265/60R18	110H	Continental	Crosscontact	V	2023	3 mm
Spare	265/60R18	110H	Continental	Crosscontact	V	0000	4 mm
