CONDITION REPORT

Report No:
2017310677
DATE
12/10/2026

Vehicle Type	LIGHT LOAD VEHICLE	Registered Owner	MFC
Manufacturer	TOYOTA	Registration Number	KV68RYGP
Model	HILUX 2.8 GD-6 RAIDER 4X4 DSL D-CAB PU AT [2021-2023]	Register Number	
		Date Of First Licensing	
VIN	AHTBA3CD206226370	Last COR	
Engine Number		License Expiry Date	28/02/2027
Doors	4	Power / Displacement	
Color	WHITE	Paint Finish	C - COMMON
Year Model	2022	Fuel	DIESEL
Km Reading	165,617 KM	Transmission	AUTOMATIC
Cab / Body Type	DOUBLE CAB

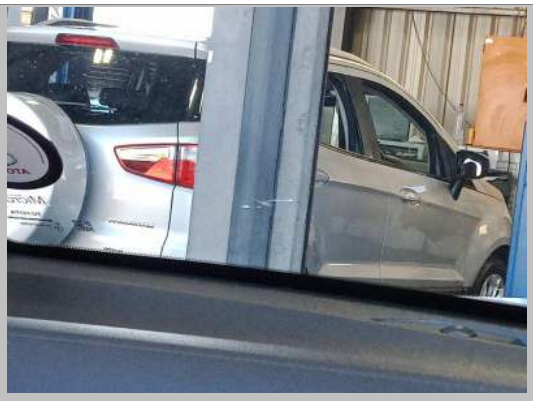
Damage	Repair Way
Front Bumper Paintwork • Scratched	Repair
Bonnet Paintwork • Scratched	Repair
Rear Fender Left Dented	Repair
Rear Fender Right Dented	Repair
Door Front Left Paintwork • Scratched	Repair
Door Front Right Dented	Repair
Door Rear Right Paintwork • Chipmarks	Repair
Rear bumper Dented	Repair
Windscreen Chipped	Repair
Brakes	No brake test done vehicle is 4wd
