CONDITION REPORT

Report No: 2016226349

Vehicle Type	**PASSENGER VEHICLE**	Registered Owner	**MFC**
Manufacturer	**TOYOTA**	Registration Number	**JL23NDGP**
Model	**COROLLA**	Register Number	
VIN	**AHTBC0JE800005749**	Date Of First Licensing	
Engine Number		Last COR	
Doors	**4**	License Expiry Date	**31/05/2024**
Color	**SILVER**	Power / Displacement	
Year Model		Paint Finish	**M - METALLIC**
Km Reading	**259,542 KM**	Fuel	**DIESEL**
Cab / Body Type	**SEDAN**	Transmission	**MANUAL**

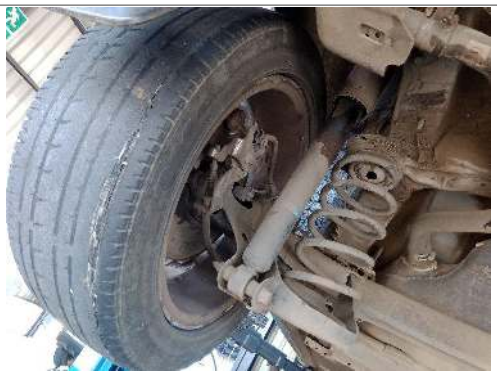
LF TYRE TREAD

Size	Load/Speed Index	Manufacture	Model	Type*	Production Date	Tread Depth (mm)
Front Left	205/55R16	91V	Sumitomo	BC100		1121	0 mm
Front Right	205/55R16	91V	Fullrun	Frun one	V	3019	1 mm
Rear Left	205/55R16	91V	Sumitomo	HTR	V	1319	0 mm
Rear Right	205/55R16	91V	Continental	Contact	V	3718	1 mm
Spare	205/55R16	91W	Dunlop	Sport	V	////////	2 mm
