CONDITION REPORT

Report No:
2017317486
DATE
26/10/2026

Vehicle Type	PASSENGER VEHICLE	Registered Owner	MFC AUCTION HOUSE
Manufacturer	TOYOTA	Registration Number	FPW825L
Model	FORTUNER 2.4 GD-6 RB DSL AT [2020-2022]	Register Number	
VIN	AHTCB3GS002015735	Date Of First Licensing	
Engine Number		Last COR	
Doors	5	License Expiry Date	
Color	SILVER	Power / Displacement	
Year Model	2021	Paint Finish	TWO COAT UNI
Km Reading	156,661 KM	Fuel	DIESEL
Cab / Body Type	STATION WAGON	Transmission	AUTOMATIC

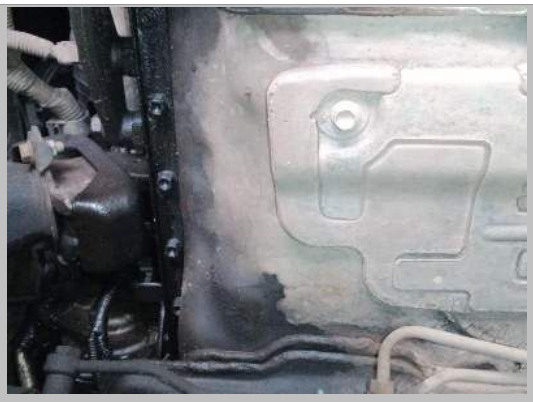
Tyre Rear Left Worn	Replace
Bolt(s) / Nut(s) Rear Wheel Left Missing	Replace
Chassis Damaged	Repair
Gearbox Oil Sweat	Repair
Engine Noise Excessive	Repair
Jack Missing	Replace
Vehicle license disk missing	Replace
Front left and right tyre sizes different	Repair
