CONDITION REPORT

Report No:
2017313061
DATE
16/10/2026

Vehicle Type	LIGHT LOAD VEHICLE	Registered Owner	
Manufacturer	TOYOTA	Registration Number	HMT959L
Model	HILUX 2.0 VVTI S AC PU [2021-2023]	Register Number	
VIN	AHTCW8CB701966057	Date Of First Licensing	
Engine Number		Last COR	
Doors	2	License Expiry Date	31/10/2026
Color	WHITE	Power / Displacement	
Year Model	2022	Paint Finish	C - COMMON
Km Reading	133,268 KM	Fuel	PETROL
Cab / Body Type	SINGLE CAB	Transmission	MANUAL

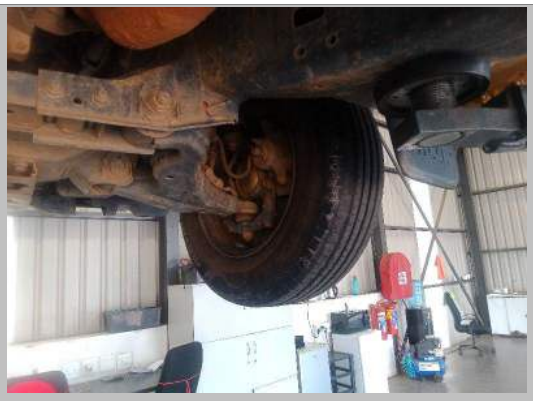
LF TYRE TREAD

Size	Load/Speed Index	Manufacture	Model	Type*	Production Date	Tread Depth (mm)
Front Left	205/70R15	96H	Royal black	Royal mile	V	0924	2 mm
Front Right	205/70R15	96H	Royal black	Royal mile	V	1024	2 mm
Rear Left	205/70R15	96H	Royal black	Royal mile	V	1024	2 mm
Rear Right	205/70R15	96H	Royal black	Royal mile	V	1024	2 mm
Spare	205/70R15	106/104R	Hilo	Brawn xc1	V	0000	4 mm
