CONDITION REPORT

Report No:
2017317655
DATE
27/10/2026

Vehicle Type	PASSENGER VEHICLE	Registered Owner	
Manufacturer	TOYOTA	Registration Number	KD21GHGP
Model	HILUX 2.8 GD-6 RB RAIDER X-CAB DSL PU AT [2017-2019]	Register Number	
		Date Of First Licensing	
VIN	AHTGA3DC900874013	Last COR	
Engine Number		License Expiry Date	31/07/2026
Doors	4	Power / Displacement	
Color	WHITE	Paint Finish	TWO COAT UNI
Year Model	2018	Fuel	DIESEL
Km Reading	286,077 KM	Transmission	AUTOMATIC
Cab / Body Type	SUPER CAB

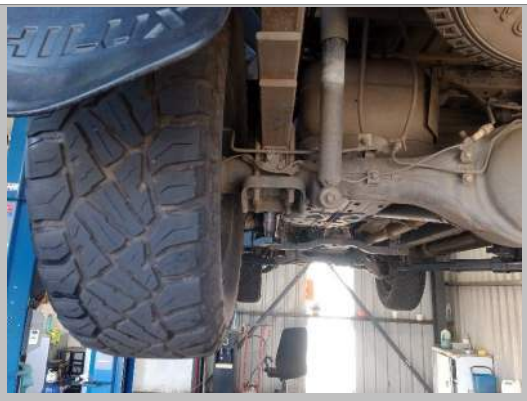
LR TYRE TREAD

Size	Load/Speed Index	Manufacture	Model	Type*	Production Date	Tread Depth (mm)
Front Left	265/65R18	116Q	Sailun	Radial	V	4724	2 mm
Front Right	265/65R18	116Q	Silun	Radial	V	4724	2 mm
Rear Left	265/65R18	116Q	Sailun	Radial	V	4724	3 mm
Rear Right	265/65R18	116Q	Sailun	Radial	V	4724	3 mm
Spare	245/70R16	106T	Continental	Worldcontac	V	4112	2 mm

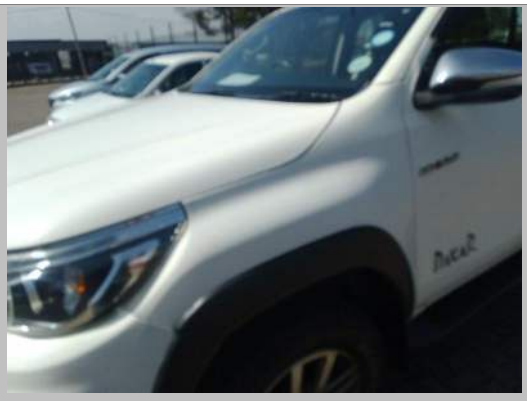
Damage	Repair Way
Tail Light Left Damaged	Repair
Brake Light Centre Damaged	Replace
Seat Front Right Damaged	Repair
Interior Mirror Damaged	Repair
Front Bumper Damaged	Repair
Bonnet Damaged	Repair
Front Fender Left Damaged	Repair
Front Fender Right Damaged	Repair
Rear Fender Left Damaged	Repair
Rear Fender Right Damaged	Repair
Door Front Left Damaged	Repair
Door Front Right Damaged	Repair
Door Rear Left Damaged	Repair
Door Rear Right Damaged	Repair
Tailgate Damaged	Repair
Windscreen Damaged	Repair
Parking Brake Performance Left / Right Difference out of legal range	Repair
Silencer Defective	Replace
Catalytic converter Missing	Repair
