CONDITION REPORT

Report No:
2017310759
DATE
12/10/2026

Vehicle Type	PASSENGER VEHICLE	Registered Owner	MFC
Manufacturer	TOYOTA	Registration Number	LG85YNGP
Model	FORTUNER 2.8 GD-6 RB DSL AT [2021-2023]	Register Number	
VIN	AHTJA3GS600242479	Date Of First Licensing	
Engine Number		Last COR	
Doors	5	License Expiry Date	31/07/2027
Color	WHITE	Power / Displacement	
Year Model	2022	Paint Finish	TWO COAT UNI
Km Reading	127,383 KM	Fuel	DIESEL
Cab / Body Type	SUV	Transmission	AUTOMATIC

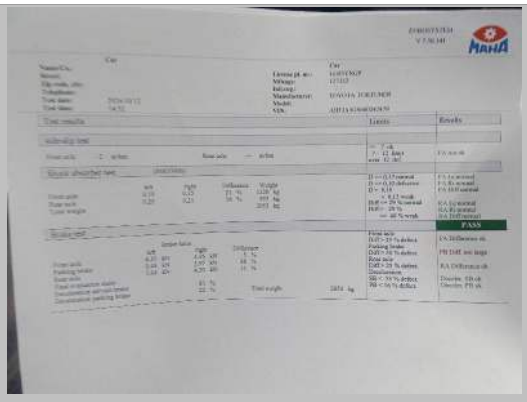
Brake test.

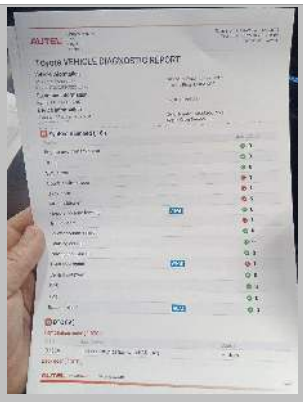
No	System	Code	Description	Status
1	COMBINATION METER	B150A	LOSS COMMUNICATION WITH HMI-LAN

Diagnostic.

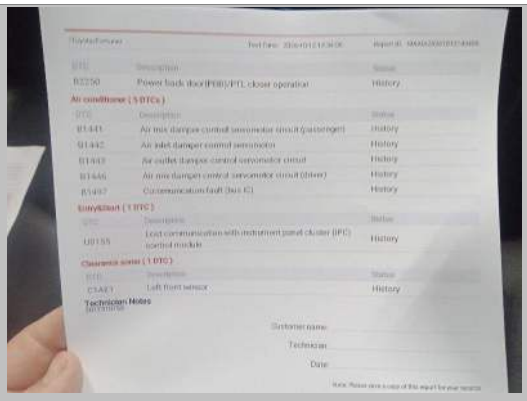
During the diagnostic the following error messages were detected: (See also attached Diagnostic Report. For more information regarding the Fault Codes (DTC) and the recommended rectifications please contact the workshops of the vehicle manufacture).

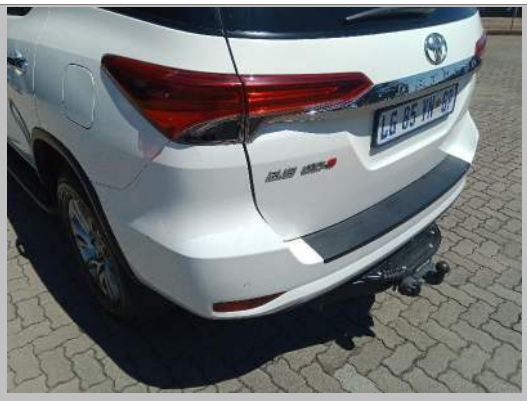
Damage	Repair Way
Headlight Left Damaged	Replace
Headlight Right Damaged	Replace
Front Bumper Damaged	Repair
Bonnet Damaged	Repair
Front Fender Left Damaged	Repair
Door Front Left Damaged	Repair
Door Front Right Damaged	Repair
Door Rear Left Damaged	Repair
Door Rear Right Damaged	Repair
Boot Lid / Hatch door Damaged	Repair
Rear bumper Damaged	Repair
