CONDITION REPORT

Report No:
2017317467
DATE
26/10/2026

Vehicle Type	PASSENGER VEHICLE	Registered Owner	
Manufacturer	TOYOTA	Registration Number	JD37PLGP
Model	COROLLA QUEST 1.6 PLUS [2016-2021]	Register Number	
VIN	AHTLB52E103141531	Date Of First Licensing	
Engine Number		Last COR	
Doors	4	License Expiry Date	30/09/2026
Color	BLUE	Power / Displacement	
Year Model	2019	Paint Finish	TWO COAT METALLIC
Km Reading	268,172 KM	Fuel	PETROL
Cab / Body Type	SEDAN	Transmission	MANUAL

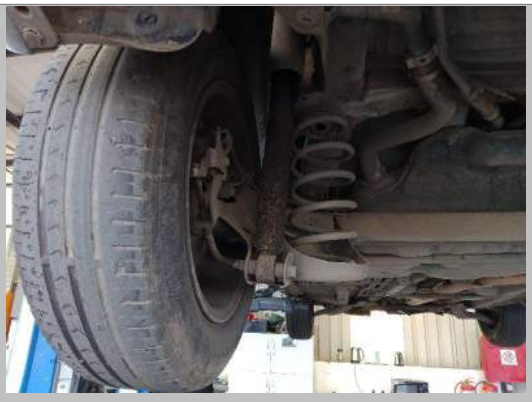
Damage	Repair Way
Engine oil sump damaged	Replace
Front and rear tyre sizes different	Repair
