CONDITION REPORT

Report No:
2017326448
DATE
17/11/2026

MFC Auction House
M57 Pretoria Rd, Glenmarais, KEMPTON PARK
Gauteng

Vehicle Type	PASSENGER VEHICLE	Registered Owner	MFC AUCTION HOUSE
Manufacturer	TOYOTA	Registration Number	JK23BYGP
Model	COROLLA QUEST 1.6 AT [2016-2021]	Register Number	
VIN	AHTLB52EX03135775	Date Of First Licensing	
Engine Number		Last COR	
Doors	4	License Expiry Date	31/05/2026
Color	WHITE	Power / Displacement	
Year Model	2018	Paint Finish	TWO COAT UNI
Km Reading	158,347 KM	Fuel	PETROL
Cab / Body Type	SEDAN	Transmission	AUTOMATIC

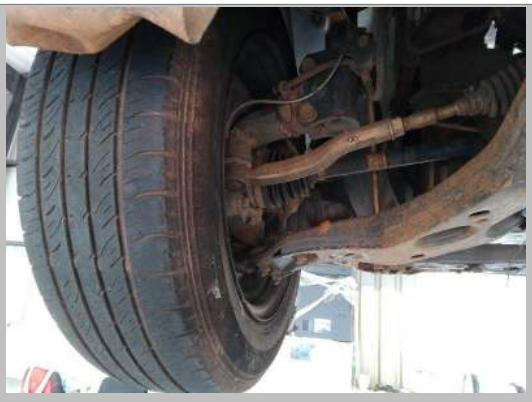
LF TYRE TREAD

Size	Load/Speed Index	Manufacture	Model	Type*	Production Date	Tread Depth (mm)
Front Left	185/65 R15	92T	Sumitomo	BC10	V	4925	3 mm
Front Right	185/65 R15	92T	Sumitomo	BC10	V	0425	4 mm
Rear Left	185/65 R15	92T	Sumitomo	BC10	V	0425	4 mm
Rear Right	185/65 R15	92T	Sumitomo	BC10	V	4924	4 mm
Spare	185/65 R15	88H	Roadshine	RS906	V	1823	0 mm

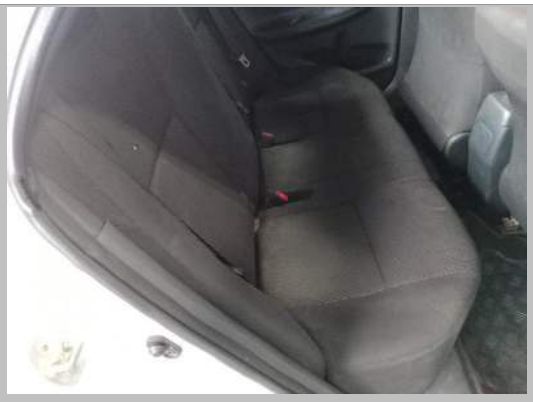
Damage	Repair Way
Engine Oil Leak	Repair
Bonnet hinges Damaged	Replace
Central Air Vent Defective	Repair
Center Console / Cubbyhole + Lid Damaged	Repair
Headlight Left Damaged	Replace
Headlight Right Damaged	Replace
Seat Front Left Damaged	Repair
Seat Front Right Damaged	Repair
Seat Rear Damaged	Repair
Sun Visor Right Damaged	Replace
Hood Lining Damaged	Repair
Door Sealing Rubber Rear Left Damaged	Replace
Door Sealing Rubber Rear Right Damaged	Replace
Steering Wheel Trim Excessive Wear & Tear	Repair
Front Bumper Damaged	Replace
Grill Damaged	Replace
Bonnet Damaged	Repair
Bonnet slam plate (Shock tower/ Inner tray) Damaged	Repair
Front Fender Right Damaged	
Rear Fender Left Damaged	Repair
Rear Fender Right Residual Traces of Repair	Repair
Front Fender Left / Inner Tray Damaged	Replace
Front Fender Right / Inner Tray Damaged	Replace
Door Front Left Damaged	Repair
Door Front Right Dented	Repair
Door Rear Left Damaged	Repair
