CONDITION REPORT

Report No: 2017315065
DATE 21/10/2026

Vehicle Type	MINI BUS	Registered Owner	MFC AUCTION HOUSE
Manufacturer	TOYOTA	Registration Number	JX61GWGP
Model	HI-ACE 2.5 SESFIKILE 16-S DSL MINIBUS [2020-2022]	Register Number	
		Date Of First Licensing	
VIN	AHTSS22P007119444	Last COR	
Engine Number		License Expiry Date	28/02/2027
Doors	4	Power / Displacement	
Color	WHITE	Paint Finish	C - COMMON
Year Model	2021	Fuel	DIESEL
Km Reading	523,015 KM	Transmission	MANUAL
Cab / Body Type	OTHERS

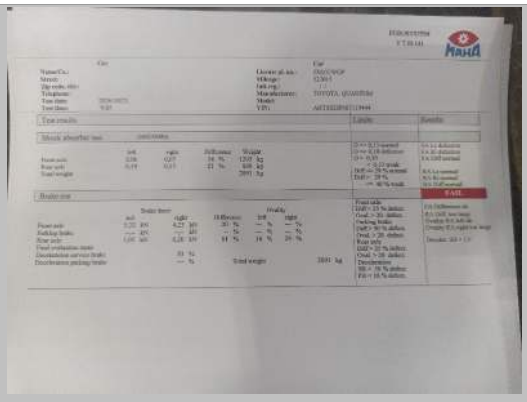
Diagnostics

During the diagnostic the following error messages were detected: (See also attached Diagnostic Report. For more information regarding the Fault Codes (DTC) and the recommended rectifications please contact the workshops of the vehicle manufacture).

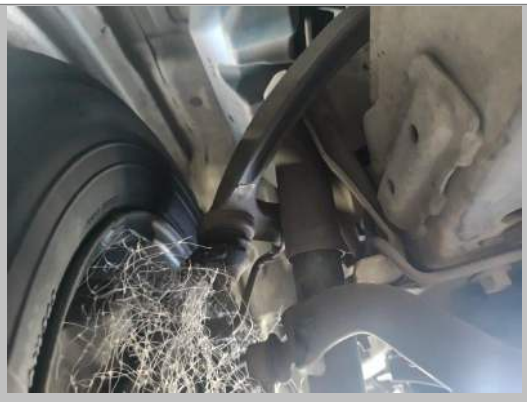
Damage	Repair Way
Engine Oil Sweat	Repair
Caps Defective	Replace
Windscreen Wiper Worn	Replace
Tail Light Left Cracked	Replace
Tail Light Right Cracked	Replace
Headlight Left Broken	Replace
Headlight Right Defective	Replace
Seat Front Left Worn	Repair
Seat Front Right Torn / Cut	Repair
Seat Rear Excessive Wear & Tear	Repair
Seat Rear (2. Row) Excessive Wear & Tear	Repair
Door Panel Front Left Damaged	Repair
Door Panel Rear Left Missing	Replace
Door Sealing Rubber Rear Left Excessive Wear & Tear	Replace
Door Lock Front Left Damaged	Repair
Door Lock Front Right Damaged	Repair
Door Lock Boot Lid Damaged	Repair
Dash Padding Defective	Repair
Window Winder front left Missing	Replace
Window Winder front right Missing	Replace
Boot Panel Left Damaged	Repair
Gear Lever Dust Boot Torn / Cut	Replace
Clutch Pedal Rubber Missing	Replace
Brake Pedal Rubber Worn	Replace
Side Mirror Left Damaged	Repair
Front Bumper Cracked	Replace

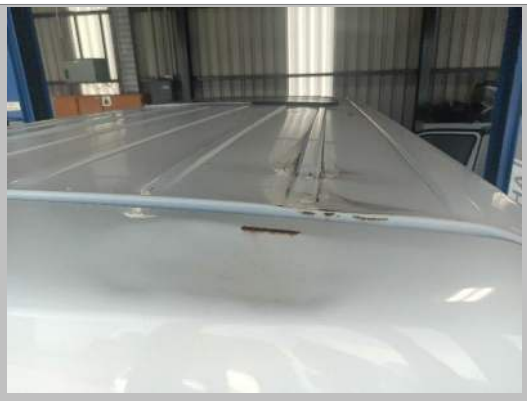
Sliding Door Damaged	Repair
Roof Dented	Repair
Windscreen Cracked	Replace
Caliper 1. Axle left Defective	Repair
Parking Brake Performance Left / Right Difference out of legal range	Repair
