CONDITION REPORT

Report No:
2017307483
DATE
05/10/2026

Vehicle Type	PASSENGER VEHICLE	Registered Owner	MFC
Manufacturer	TOYOTA	Registration Number	NONE
Model	HI-ACE 2.5 SESFIKILE 16-S DSL MINIBUS [2021-2024]	Register Number	
		Date Of First Licensing	
VIN	AHTSS22P207149447	Last COR	
Engine Number		License Expiry Date	30/06/2027
Doors	4	Power / Displacement	
Color	WHITE	Paint Finish	TWO COAT UNI
Year Model	2023	Fuel	DIESEL
Km Reading	356,546 KM	Transmission	MANUAL
Cab / Body Type	STATION WAGON

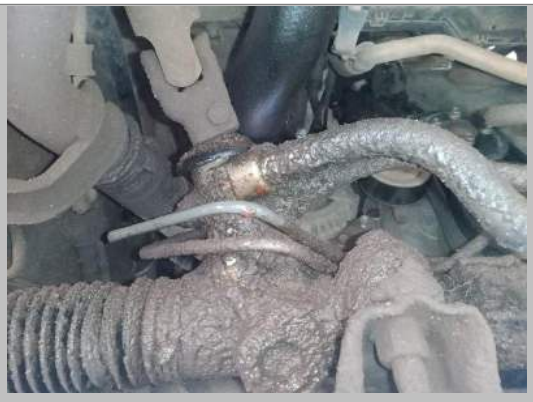
Damage	Repair Way
Mounting Rubber(s) Rear Axle Left Loose / Excessive Play	Repair
Tyre Front Left Damaged	Replace
Tyre Front Right Worn	Replace
Bolt(s) / Nut(s) Rear Wheel Left Missing	Replace
Sub Frame Damaged	Repair
Catalytic converter Missing	Replace
Gearbox Mountings Cracked	Replace
Gearbox Oil Leak	Repair
Fuel Tank Dented	Repair
Center Prop Shaft Bearing(s) Damaged	Replace
Radiator Cradle Damaged	Repair
Brakes Insufficient	Repair
Gear Selections Malfunction	Repair
Differential Noise Excessive	Repair
Jack Missing	Replace
Wheel Spanner Missing	Replace
Warning lights illuminated on dashboard	Repair
Front and rear shock absorbers weak	Replace
Spare wheel missing	Replace
