CONDITION REPORT

Report No:
2017309124
DATE
09/10/2026

MFC Auction House
M57 Pretoria Rd, Glenmarais, KEMPTON PARK
Gauteng

Vehicle Type	PASSENGER VEHICLE	Registered Owner	MFC
Manufacturer	TOYOTA	Registration Number	LT40HSGP
Model	HI-ACE 2.5 SESFIKILE 16-S DSL MINIBUS [2021-2024]	Register Number	
		Date Of First Licensing	
VIN	AHTSS22P407152432	Last COR	
Engine Number		License Expiry Date	
Doors	4	Power / Displacement	
Color	WHITE	Paint Finish	C - COMMON
Year Model	2023	Fuel	DIESEL
Km Reading	311,718 KM	Transmission	MANUAL
Cab / Body Type	OTHERS

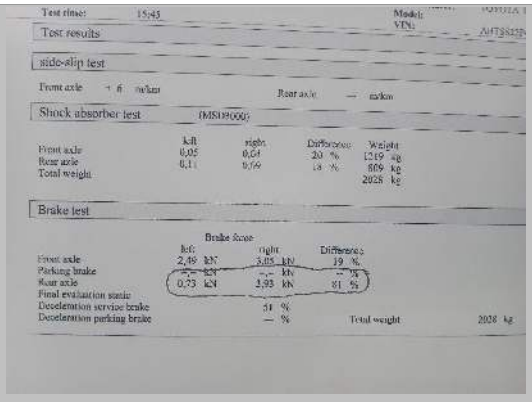
Parking Brake Performance

Left	Right		
	Braking Force [KN]	Braking Force [KN]	Axle Weight [KG]	Deceleration [m/s²]
Front	2.4	3.0	-	
Rear	0.7	3.9	-	
Emergency / Parking	0	0	-
