CONDITION REPORT

Report No:
2017311535
DATE
14/10/2026

Vehicle Type	PASSENGER VEHICLE	Registered Owner	
Manufacturer	MAZDA	Registration Number	JTP238MP
Model	MAZDA3 1.6 DYNAMIC 5-DR AT [2016-2019]	Register Number	
VIN	JM6BN24Z5J0188397	Date Of First Licensing	
Engine Number		Last COR	
Doors	5	License Expiry Date	30/09/2026
Color	RED	Power / Displacement	
Year Model	2017	Paint Finish	M - METALLIC
Km Reading	190,435 KM	Fuel	PETROL
Cab / Body Type	HATCHBACK	Transmission	AUTOMATIC

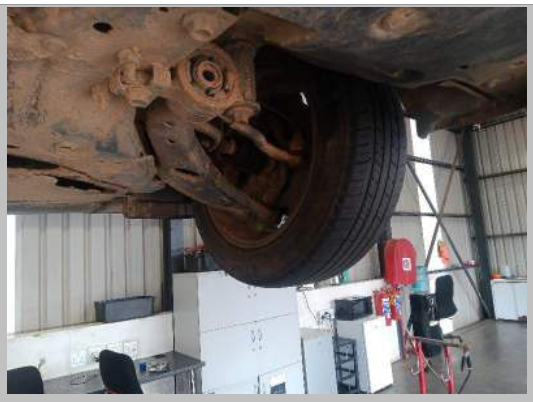
LF TYRE TREAD

Size	Load/Speed Index	Manufacture	Model	Type*	Production Date	Tread Depth (mm)
Front Left	205/55R16	91V	Rapid	Eco809	V	1124	2 mm
Front Right	205/55R16	91V	Rapid	Eco809	V	1124	2 mm
Rear Left	205/55R16	91V	Rapid	Eco809	V	1124	3 mm
Rear Right	205/55R16	91V	Rapid	Eco809	V	1124	3 mm
Spare	T125/70D16	96M	Dunlop	Temporary	V	0000	2 mm

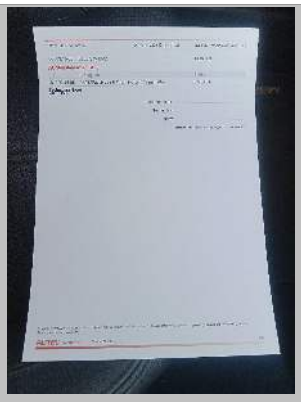
Diagnostic Report page 1

During the diagnostic the following error messages were detected: (See also attached Diagnostic Report. For more information regarding the Fault Codes (DTC) and the recommended rectifications please contact the workshops of the vehicle manufacture).

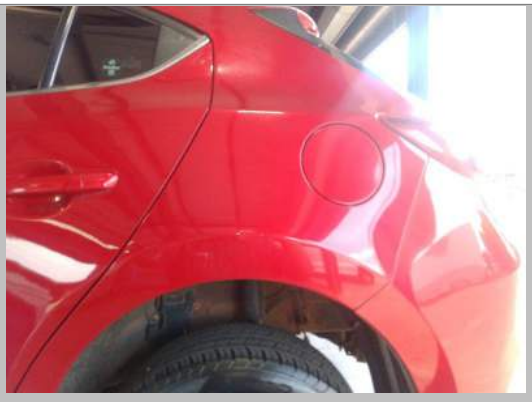
Damage	Repair Way
Side Mirror Left Paintwork • Scratched	Repair
Front Bumper Paintwork • Chipmarks	Repair
Bonnet Paintwork • Scratched	Repair
Front Fender Left Paintwork • Scratched	Repair
Front Fender Right Paintwork • Scratched	Repair
Rear Fender Left Dented	Repair
Rear Fender Right Paintwork • Scratched	Repair
Door Front Left Paintwork • Scratched	Repair
Door Front Right Paintwork • Scratched	Repair
Door Rear Left Paintwork • Scratched	Repair
Door Rear Right Paintwork • Scratched	Repair
Sealing / Rubber Rear Door Left Defective	Repair
Boot Lid / Hatch door Paintwork • Scratched	Repair
Rear bumper Paintwork • Scratched	Repair
Windscreen Chipped	Repair
Service Brake Performance Front Axle Left / Right Difference out of legal range	Repair
Stabilizer Mounting Front Left Damaged	Replace
Stabilizer Mounting Front Right Damaged	Replace
Control Arm Bush(es) Front Axle Left Damaged	Replace
Control Arm Bush(es) Front Axle Right Damaged	Replace
