CONDITION REPORT

Report No:
2017317030
DATE
26/10/2026

Vehicle Type	PASSENGER VEHICLE	Registered Owner	
Manufacturer	MAZDA	Registration Number	LW46NYGP
Model	CX-5 2.0L ACTIVE AT [2018-2020]	Register Number	
VIN	JM6KF2W7AK0308421	Date Of First Licensing	
Engine Number		Last COR	
Doors	5	License Expiry Date	30/06/2025
Color	WHITE	Power / Displacement	
Year Model	2019	Paint Finish	C - COMMON
Km Reading	486,719 KM	Fuel	PETROL
Cab / Body Type	STATION WAGON	Transmission	AUTOMATIC

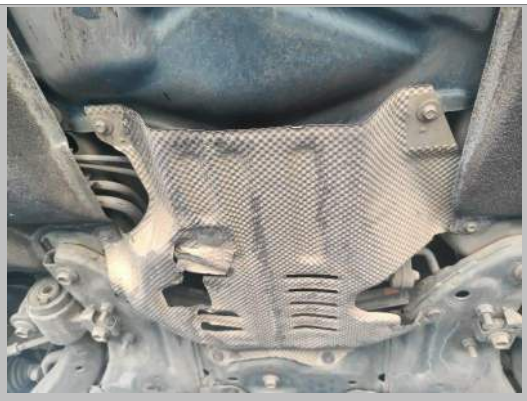
License plates

Tyre Front Right Smooth	Replace
Tyre Rear Left Smooth	Replace
Tyre Rear Right Smooth	Replace
Number plates front and back not fitted	Replace
Exhaust Heat Guard/Shield damged	Repair
Warning light illuminated	Repair

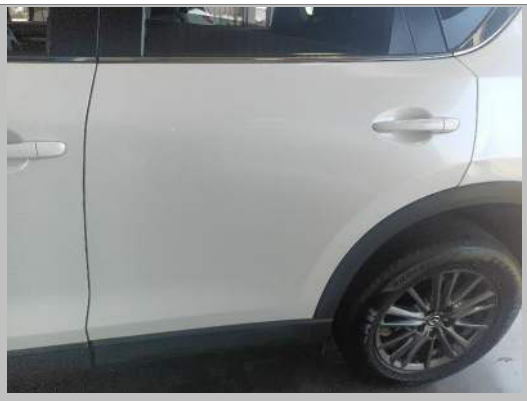
Damage	Repair Way
Windscreen Wiper Worn	Replace
Seat Front Right Worn	Repair
Parcel Tray Damaged	Replace
Front Bumper Paintwork • Scratched	Repair
Bonnet Paintwork • Chipmarks	Repair
Front Fender Left Paintwork • Scratched	Repair
Front Fender Right Dented	Repair
Rear Fender Left Dented	Repair
Front Fender Left / Inner Tray Damaged	Replace
Door Front Left Paintwork • Scratched	Repair
Door Front Right Dented	Repair
Door Rear Left Dented	Repair
Door Rear Right Damaged	Repair
Boot Lid / Hatch door Damaged	Repair
Rear bumper Cracked	Repair
Roof Paintwork • Scratched	Repair
Windscreen Cracked	Replace
Brake disc 1. Axle left Worn	Replace
Brake disc 1. Axle right Worn	Replace
Brake disc 2. Axle left Worn	Replace
Brake disc 2. Axle right Worn	Replace
Brake Pad 1. Axle left Worn	Replace
Brake Pad 1. Axle right Worn	Replace
Brake Pad/Shoe 2. Axle left Worn	Replace
Brake Pad/Shoe 2. Axle right Worn	Replace
Tyre Front Left Smooth	Replace
