CONDITION REPORT

Report No:
2017315999
DATE
22/10/2026

Vehicle Type	PASSENGER VEHICLE	Registered Owner	MFC AUCTION HOUSE
Manufacturer	MAZDA	Registration Number	LG83FPGP
Model	CX-5 2.2L DE AKERA AWD DSL AT [2022-2024]	Register Number	
		Date Of First Licensing	
VIN	JM6KF4W2AP0879999	Last COR	
Engine Number		License Expiry Date	31/12/2026
Doors	5	Power / Displacement	
Color	GREY	Paint Finish	TWO COAT METALLIC
Year Model	2023	Fuel	DIESEL
Km Reading	118,885 KM	Transmission	AUTOMATIC
Cab / Body Type	STATION WAGON

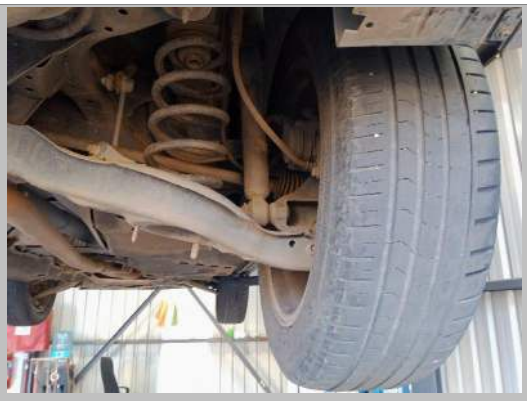
Undercarriage front.

Undercarriage rear.

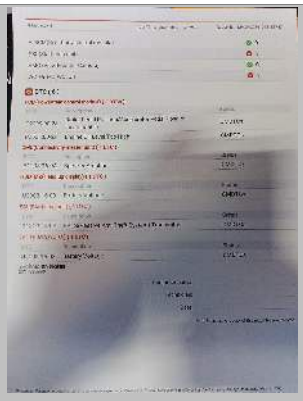
Diagnostic.

No	System	Code	Description	Status
1	PCM	P2299:00-28	BRIGHT PEDAL POSITION/ ACCELERATOR PEDAL POSITION

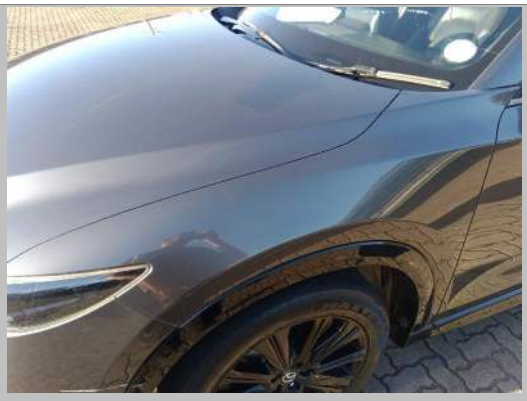
Damage	Repair Way
Tail Light Right Damaged	Replace
Seat Front Left Damaged	Repair
Front Bumper Damaged	Repair
Bonnet Damaged	Repair
Front Fender Left Damaged	Repair
Front Fender Right Damaged	Repair
Rear Fender Left Damaged	Repair
Rear Fender Right Damaged	Repair
Door Front Left Damaged	Repair
Door Front Right Damaged	Repair
Door Rear Left Damaged	Repair
Door Rear Right Damaged	Repair
Boot Lid / Hatch door Damaged	Repair
Rear bumper Damaged	Repair
Windscreen Damaged	Repair
Tyre Front Left Worn	Replace
Tyre Rear Left Worn	Replace
Oil service warning light illuminated	Repair

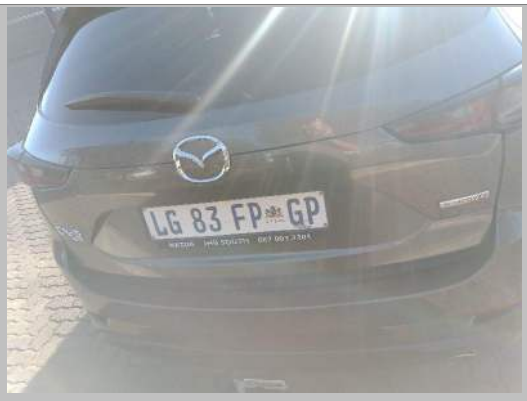
Rear Fender Left

Rear bumper
