CONDITION REPORT

Report No:
2017315308
DATE
21/10/2026

Vehicle Type	PASSENGER VEHICLE	Registered Owner	MFC AUCTION HOUSE
Manufacturer	NISSAN	Registration Number	JV36YTGP
Model	X-TRAIL 2.5 SE AWD 7-S CVT [2014-2018]	Register Number	
VIN	JN1JBNT32Z0006222	Date Of First Licensing	
Engine Number		Last COR	
Doors	5	License Expiry Date	
Color	WHITE	Power / Displacement	
Year Model	2016	Paint Finish	M - METALLIC
Km Reading	186,674 KM	Fuel	PETROL
Cab / Body Type	STATION WAGON	Transmission	AUTOMATIC

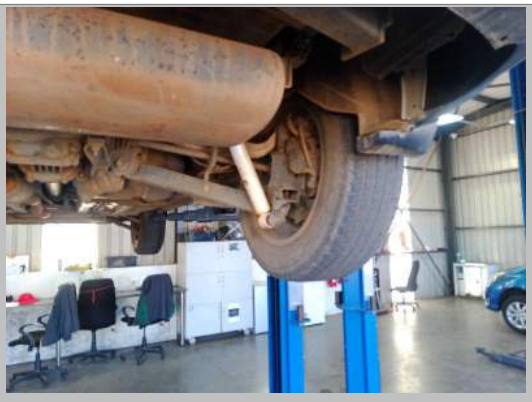
LF TYRE TREAD

Size	Load/Speed Index	Manufacture	Model	Type*	Production Date	Tread Depth (mm)
Front Left	225/60R18	104H	Powertrac	City rover	V	2625	4 mm
Front Right	225/60R18	104H	Powertrac	City rover	V	2625	4 mm
Rear Left	225/60R18	100V	Michelin	Pilot sport	V	2919	4 mm
Rear Right	225/60R18	100H	Yokohama	Bluearth	V	3216	4 mm
Spare	T155/90D17	101M	Maxxis	Temporary	V	////	4 mm

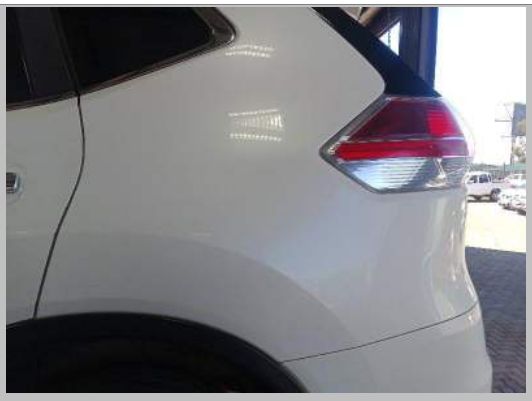
Damage	Repair Way
Front Bumper Paintwork • Scratched	Repair
Bonnet Paintwork • Chipmarks	Repair
Front Fender Left Paintwork • Chipmarks	Repair
Front Fender Right Paintwork • Scratched	Repair
Rear Fender Left Paintwork • Scratched	Repair
Door Front Left Paintwork • Chipmarks	Repair
Door Front Right Paintwork • Scratched	Repair
Door Rear Left Dented	Repair
Door Rear Right Paintwork • Chipmarks	Repair
Boot Lid / Hatch door Paintwork • Scratched	Repair
Rear bumper Paintwork • Scratched	Repair
Brakes	No brake test done vehicle is 4wd
Rear tires deferred name brand	Repair
