CONDITION REPORT

Report No:
2017319447
DATE
29/10/2026

Vehicle Type	PASSENGER VEHICLE	Registered Owner	MFC AUCTION HOUSE
Manufacturer	NISSAN	Registration Number	CBH607L
Model	X-TRAIL 2.0 XE [2009-2012]	Register Number	
VIN	JN1TBAT31Z0710593	Date Of First Licensing	
Engine Number		Last COR	
Doors	5	License Expiry Date	
Color	SILVER	Power / Displacement	
Year Model	2010	Paint Finish	TWO COAT METALLIC
Km Reading	264,683 KM	Fuel	PETROL
Cab / Body Type	SUV	Transmission	MANUAL

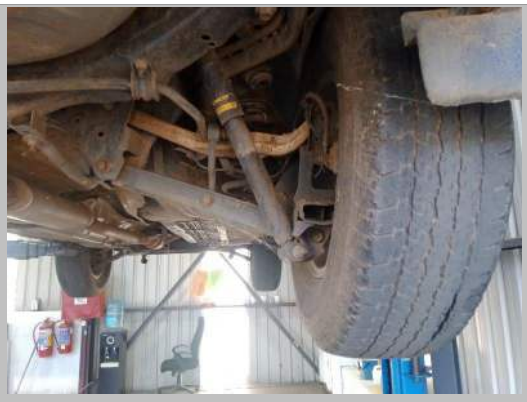
LR TYRE TREAD

Size	Load/Speed Index	Manufacture	Model	Type*	Production Date	Tread Depth (mm)
Front Left	245/70R16	111S	Bridgestone	Radial	V	1614	1 mm
Front Right	245/70R16	111S	Bridgestone	Radial	V	1714	1 mm
Rear Left	245/70R16	111S	Bridgestone	Radial	V	1714	1 mm
Rear Right	245/70R16	111S	Bridgestone	Radial	V	1714	1 mm

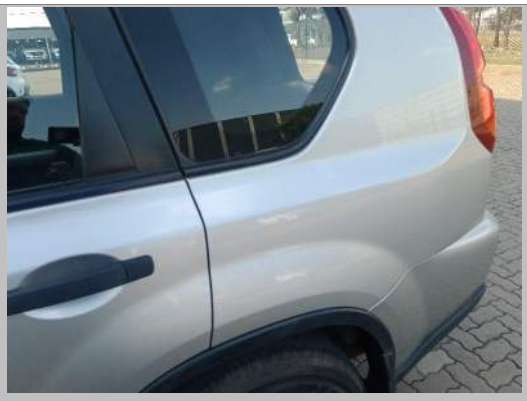
Damage	Repair Way
Engine Oil Leak	Repair
Windscreen Wiper Damaged	Replace
Seat Front Right Damaged	Repair
Carpet Rear Missing	Replace
Front Bumper Damaged	Repair
Bonnet Damaged	Repair
Front Fender Left Damaged	Repair
Front Fender Right Damaged	Repair
Rear Fender Left Damaged	Repair
Rear Fender Right Damaged	Repair
Door Front Left Damaged	Repair
Door Front Right Damaged	Repair
Door Rear Left Damaged	Repair
Door Rear Right Damaged	Repair
Boot Lid / Hatch door Damaged	Repair
Boot Lid / Hatch Door Shock Left Defective	Repair
Boot Lid / Hatch Door Shock Right Defective	Repair
Rear bumper Damaged	Repair
Windscreen Damaged	Replace
Stabilizer Mounting Front Left Damaged	Replace
Stabilizer Mounting Front Right Damaged	Replace
Silencer Welded	Repair
Gearbox Oil Leak	Repair
CV Joint(s) Boot(s) Front Left (inner/outer) Damaged	Replace
CV Joint(s) Boot(s) Front Right (inner/outer) Damaged	Replace
Engine Smoke Excessive	Repair
Steering wheel orientation incorrect.	Repair
