CONDITION REPORT

Report No:
2017315452
DATE
21/10/2026

Vehicle Type	PASSENGER VEHICLE	Registered Owner	ACCORDING TO THE AGE AND MILEAGE OF
Manufacturer	SUZUKI	Registration Number	KLR925MP
Model	SX4 2.0I 5-DR AWD [2010-2014]	Register Number	
VIN	JSAGYB51S00302282	Date Of First Licensing	
Engine Number		Last COR	
Doors	5	License Expiry Date	31/08/2026
Color	GREY	Power / Displacement	
Year Model	2011	Paint Finish	TWO COAT UNI
Km Reading	228,983 KM	Fuel	PETROL
Cab / Body Type	HATCHBACK	Transmission	MANUAL

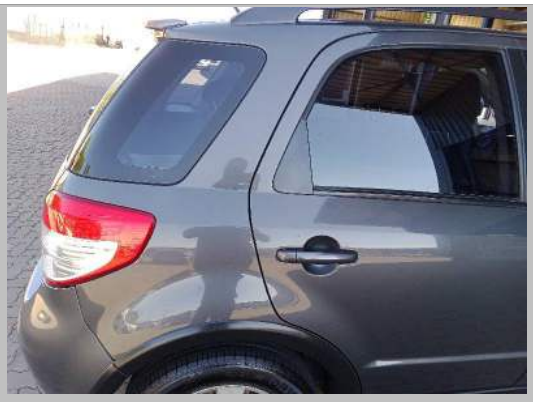
Damage	Repair Way
Engine Oil Leak	Repair
Fan Belt Damaged	Replace
Radiator Water Leak	Replace
Battery box Corrosion	Repair
Switch Electrical Window Winder rear right Missing	Replace
Windscreen Wiper Damaged	Replace
Fog Light Front Right Damaged	Replace
Headlight Left Defective	Repair
Headlight Right Defective	Repair
Seat Front Left Dirty	Repair
Seat Front Right Damaged	Repair
Seat Rear Damaged	Repair
Door Sealing Rubber Rear Left Damaged	Replace
Door Sealing Rubber Rear Right Damaged	Replace
Steering Wheel Trim Excessive Wear & Tear	Repair
Side Mirror Right Paintwork • Scratched	Repair
Front Bumper Paintwork • Scratched	Repair
Bonnet Damaged	Repair
C • Pillar Left Damaged	Repair
Front Fender Right Residual Traces of Repair	Repair
Rear Fender Right Dented	Repair
Door Front Left Paintwork • Scratched	Repair
Door Front Right Dented	Repair
Door Rear Left Paintwork • Scratched	Repair
Door Rear Right Residual Traces of Repair	Repair

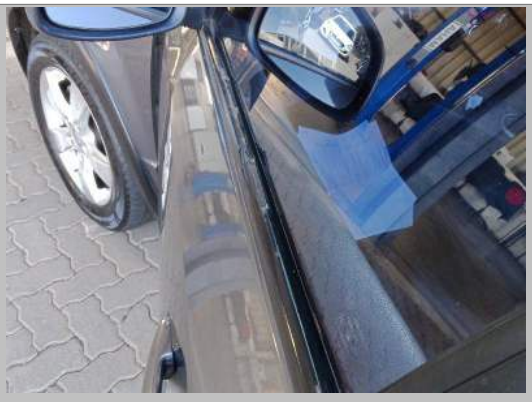
Weather Strip Door Front Left Damaged	Repair
Boot Lid / Hatch door Dented	Repair
Rear bumper Damaged	Repair
Sill Panel Left Paintwork • Scratched	Repair
Windscreen Chipped	Repair
Steering Rack Boot Right Leak	Replace
Shock Absorber Rear Right Sweat	Replace
Control Arm Bush(es) Front Axle Left Cracked	Replace
Control Arm Bush(es) Front Axle Right Cracked	Replace
Tyre Front Left Worn	Replace
Rim Rear Left Dented	Repair
Chassis Dented	Repair
Belly plates Damaged	Replace
Gearbox Oil Sweat	Repair
Differential Oil Leak	Repair
CV Joint(s) Boot(s) Front Left (inner/outer) Damaged	Replace
Triangle Missing	Replace
Warning lights illuminated on dashboard	Repair
Spare wheel missing	Replace
Driver's arm rest damaged	Repair
