# CONDITION REPORT

**Report No:**
**2017316659**
**DATE**
**23/10/2026**

*MFC Auction House*
*M57 Pretoria Rd, Glenmarais, KEMPTON PARK*
*Gauteng*

| Manufacturer | TOYOTA | Registration Number | KWB373MP |

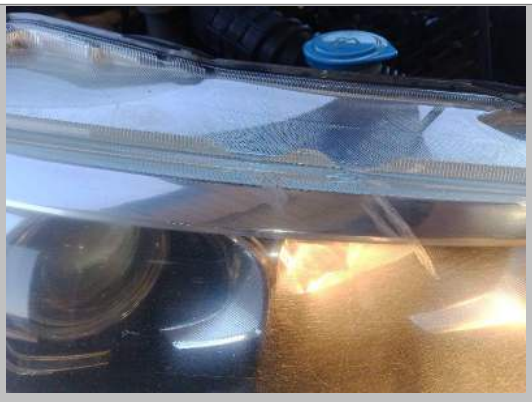
| Damage | Repair Way |
|---|---|
| Headlight Left Damaged | Replace |

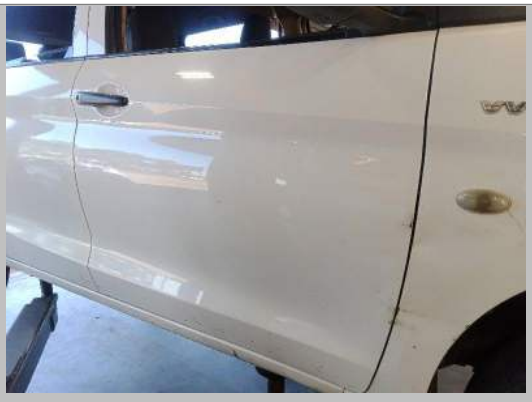
| Damage | Repair Way |
|---|---|
| Door Rear Right Paintwork • Scratched | Repair |

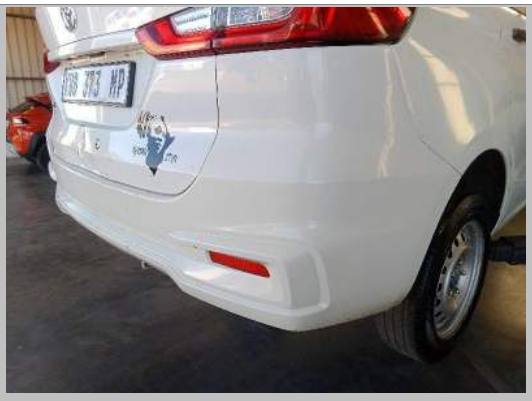
| Damage | Repair Way |
|---|---|
| Rear Fender Left Paintwork • Scratched | Repair |

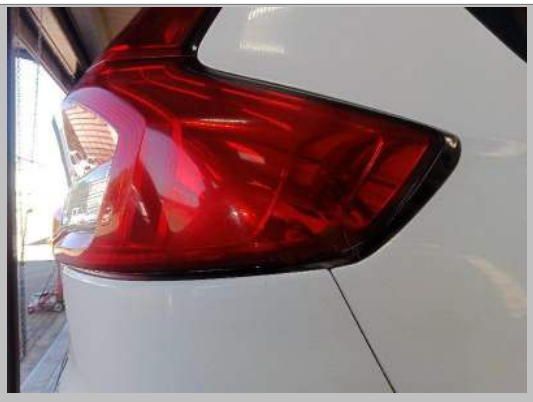
| Damage | Repair Way |
|---|---|
| Tail Light Right Damaged | Repair |
