CONDITION REPORT

Report No:
2017318690
DATE
28/10/2026

Vehicle Type	PASSENGER VEHICLE	Registered Owner	MFC AUCTION HOUSE
Manufacturer	TOYOTA	Registration Number	KXC834MP
Model	STARLET 1.4 XI 5-DR [2020-2023]	Register Number	
VIN	JTDGWC52S00826960	Date Of First Licensing	
Engine Number		Last COR	
Doors	5	License Expiry Date	31/07/2026
Color	WHITE	Power / Displacement	
Year Model	2022	Paint Finish	TWO COAT UNI
Km Reading	133,450 KM	Fuel	PETROL
Cab / Body Type	HATCHBACK	Transmission	MANUAL

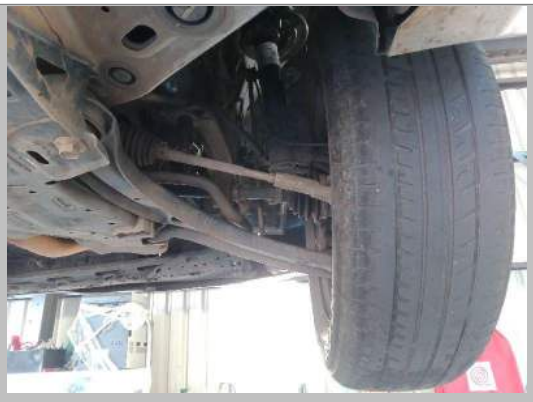
LF TYRE TREAD

Size	Load/Speed Index	Manufacture	Model	Type*	Production Date	Tread Depth (mm)
Front Left	185/65 R15	88H	Velocity	Rota-R	V	0723	0 mm
Front Right	185/65 R15	88H	Davanti	DX390	V	2828	0 mm
Rear Left	175/65 R15	84H	Royalblack	Royalmile	V	3023	2 mm
Rear Right	T135/70 R15	99M	Jk tyre	Temporary	V	4621	1 mm
Spare	185/65 R15	92T	Dunlop	Sp-Sport	V	2214	2 mm

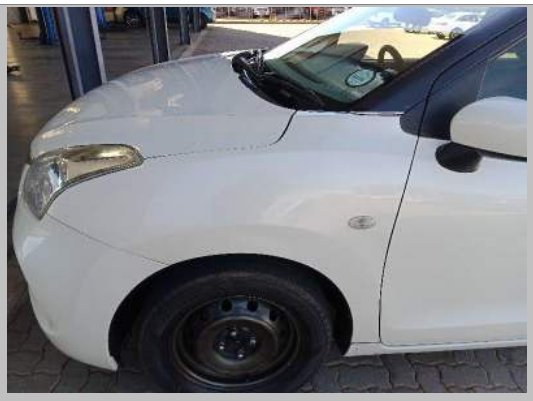
Spare Tyre Damaged	Replace
Rim Front Left Dented	Repair
Rim Rear Left Dented	Repair
Main Beam Right Residual Traces of Repair	Repair
Chassis Scratched	Repair
Sub Frame Damaged	Replace
Belly plates Damaged	Replace
Gearbox Oil Sweat	Repair
Fuel Tank Damaged	Repair
Radiator Cradle Damaged	Replace
Signs of vehicle Airbags deployed	Replace.
Airbag warning light illuminated on dashboard	Repair
Front left and right tyres regrooved	Replace
Fuel tank strap damaged	Repair
Rear left and right tyre sizes different	Repair

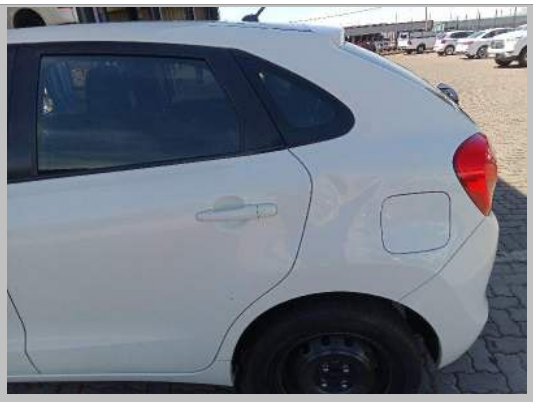
Damage	Repair Way
Engine Oil Sweat	Repair
Switch Electrical Window Winder front left Damaged	Replace
Windscreen Wiper Damaged	Replace
Windscreen Washer Damaged	Replace
Fog Light Front Left Damaged	Replace
Headlight Left Damaged	Replace
Headlight Right Damaged	Replace
Seat Rear Dirty	Repair
Dash Padding Defective	Repair
Carpet Front Damaged	Repair
Boot Carpet Damaged	Repair
Front Bumper Damaged	Replace
Grill Damaged	Replace
Bonnet Residual Traces of Repair	Repair
Front Fender Left Residual Traces of Repair	Repair
Front Fender Right Residual Traces of Repair	Repair
Rear Fender Left Damaged	Repair
Front Fender Right / Inner Tray Damaged	Repair
Door Front Right Residual Traces of Repair	Repair
Door Rear Left Dented	Repair
Door Rear Right Dented	Repair
Boot Lid / Hatch door Dented	Repair
Rear bumper Paintwork • Scratched	Repair
Windscreen Chipped	Repair
Tyre Front Left Damaged	Replace
Tyre Front Right Damaged	Replace
Tyre Rear Left Damaged	Replace
