CONDITION REPORT

Report No:
2017316400
DATE
23/10/2026

MFC Auction House
M57 Pretoria Rd, Glenmarais, KEMPTON PARK
Gauteng

Vehicle Type	PASSENGER VEHICLE	Registered Owner	MFC AUCTION HOUSE
Manufacturer	TOYOTA	Registration Number	LJG836NW
Model	STARLET 1.5 XI 5-DR [2022-2025]	Register Number	
VIN	JTDJWCA3S00601412	Date Of First Licensing	
Engine Number		Last COR	
Doors	5	License Expiry Date	30/11/2026
Color	WHITE	Power / Displacement	
Year Model	2024	Paint Finish	M - METALLIC
Km Reading	63,016 KM	Fuel	PETROL
Cab / Body Type	HATCHBACK	Transmission	MANUAL

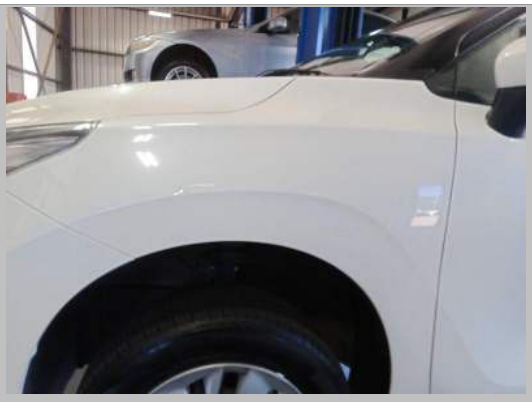
Damage	Repair Way
Side Mirror Right Paintwork • Scratched	Repair
Front Bumper Paintwork • Chipmarks	Repair
Front Fender Left Dented	Repair
Rear Fender Left Dented	Repair
Rear Fender Right Paintwork • Scratched	Repair
Rear bumper Paintwork • Scratched	Repair
Windscreen Cracked	Replace
Body exterior	Vehicle got minor scratches, stone chips and dents
L/F fender liner damage	Replace
