CONDITION REPORT

Report No:
2017317182
DATE
26/10/2026

Vehicle Type	PASSENGER VEHICLE	Registered Owner	
Manufacturer	TOYOTA	Registration Number	LZ97VYGP
Model	STARLET 1.5 XI 5-DR [2022-2025]	Register Number	
VIN	JTDJWCA3S00696747	Date Of First Licensing	
Engine Number		Last COR	
Doors	5	License Expiry Date	31/10/2026
Color	WHITE	Power / Displacement	
Year Model	2024	Paint Finish	M - METALLIC
Km Reading	58,592 KM	Fuel	PETROL
Cab / Body Type	HATCHBACK	Transmission	MANUAL

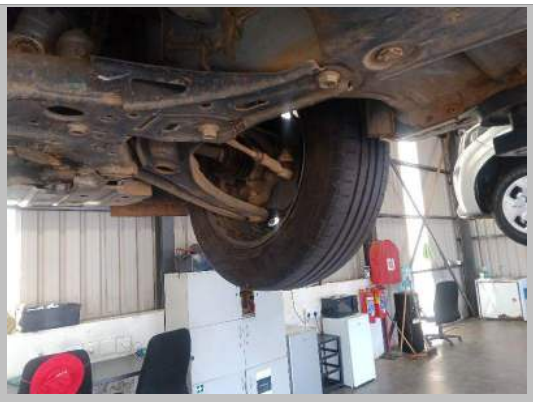
LF TYRE TREAD

Size	Load/Speed Index	Manufacture	Model	Type*	Production Date	Tread Depth (mm)
Front Left	185/65R15	88H	Apollo	Alnac	V	0524	3 mm
Front Right	185/65R15	88H	Apollo	Alnac	V	0524	3 mm
Rear Left	185/65R15	88H	Apollo	Alnac	V	0524	3 mm
Rear Right	185/65R15	88H	Apollo	Alnac	V	0524	3 mm
Spare	T125/70R15	99M	Jk tyre	Temporary	V	0124	4 mm
