CONDITION REPORT

Report No:
2017316618
DATE
26/10/2026

Vehicle Type	PASSENGER VEHICLE	Registered Owner	
Manufacturer	TOYOTA	Registration Number	N/A
Model	STARLET 1.5 XI 5-DR [2022-2025]	Register Number	
VIN	JTDJWCA3S00880301	Date Of First Licensing	
Engine Number		Last COR	
Doors	5	License Expiry Date	
Color	WHITE	Power / Displacement	
Year Model	2025	Paint Finish	M - METALLIC
Km Reading	153,970 KM	Fuel	PETROL
Cab / Body Type	HATCHBACK	Transmission	MANUAL

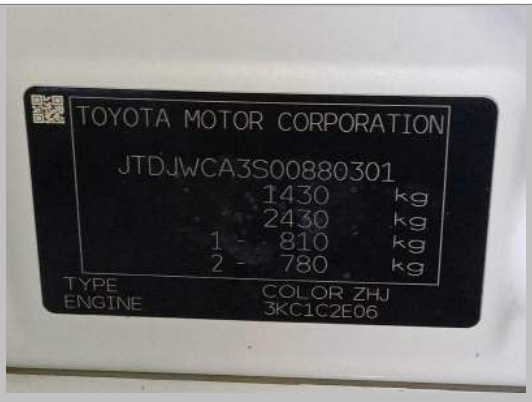
No license disc	Replace
Both number plates missing	Replace
ABS light and traction control light on	Repair
Extra spare wheel in side boot	Repair
All four tires deferred sizes	Repair

NO LICENSE DISC

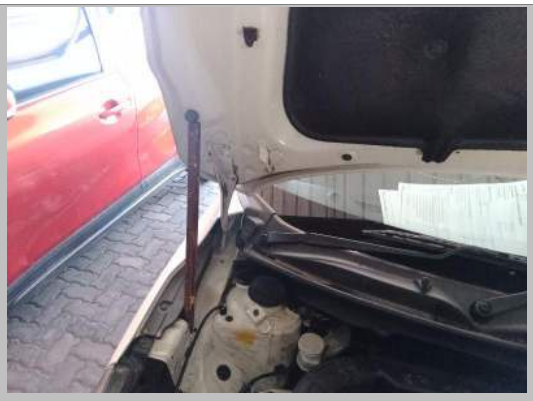
Damage	Repair Way
Bonnet stay and shocks Missing	Replace
Side Mirror Left Paintwork • Scratched	Repair
Side Mirror Right Paintwork • Scratched	Repair
Front Bumper Damaged	Repair
Front Fender Left Residual Traces of Repair	Repair
Front Fender Right Paintwork • Scratched	Repair
Rear Fender Left Dented	Repair
Rear Fender Right Dented	Repair
Door Front Left Paintwork • Scratched	Repair
Door Front Right Paintwork • Scratched	Repair
Door Rear Left Damaged	Repair
Door Rear Right Paintwork • Scratched	Repair
Boot Lid / Hatch door Paintwork • Scratched	Repair
Rear bumper Paintwork • Scratched	Repair
Inner Boot Floor Pan and Spare Wheel Well Dented	Repair
Windscreen Cracked	Replace
Tyre Front Left Smooth	Replace
Tyre Front Right Damaged	Replace
Spare Tyre Damaged	Repair
Bolt(s) / Nut(s) Rear Wheel Left Missing	Replace
Bolt(s) / Nut(s) Rear Wheel Right Missing	Replace
Belly plates Damaged	Repair
Radiator Cradle Dented	Repair

Bonnet stay and shocks

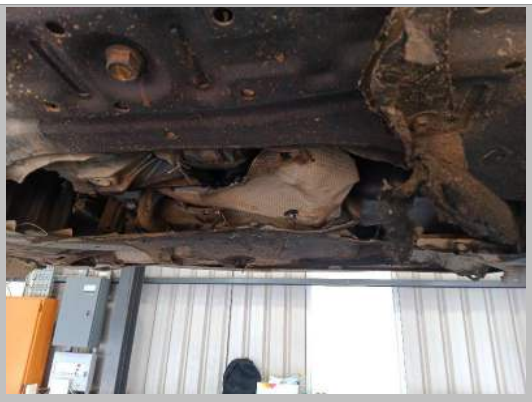
Belly plates

Radiator Cradle
