CONDITION REPORT

Report No:
2017310511
DATE
12/10/2026

Vehicle Type	LIGHT LOAD VEHICLE	Registered Owner	MFC
Manufacturer	HYUNDAI	Registration Number	LR48XCGP
Model	H-100 BAKKIE 2.6 DECK DSL PU [2011-2020]	Register Number	
VIN	KMFZBX7BLKU617550	Date Of First Licensing	
Engine Number		Last COR	
Doors	2	License Expiry Date	
Color	WHITE	Power / Displacement	
Year Model	2019	Paint Finish	TWO COAT UNI
Km Reading	162,904 KM	Fuel	DIESEL
Cab / Body Type	SINGLE CAB	Transmission	MANUAL

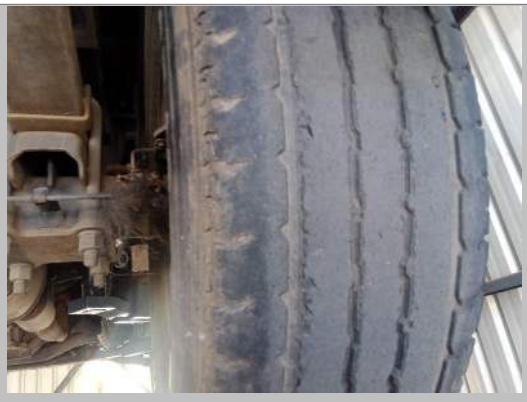
Damage	Repair Way
Engine Oil Leak	Repair
Seat Front Left Damaged	Repair
Seat Front Right Damaged	Repair
Front Bumper Damaged	Repair
Bonnet Damaged	Repair
B • Pillar Right Damaged	Repair
Door Front Left Damaged	Repair
Door Front Right Damaged	Repair
Load Body Damaged	Repair
Tyre Front Left Worn	Replace
Tyre Rear Left Worn	Replace
Tyre Rear Right Worn	Replace
Front tyres size differs	Replace
Rear tyres size differs	Replace

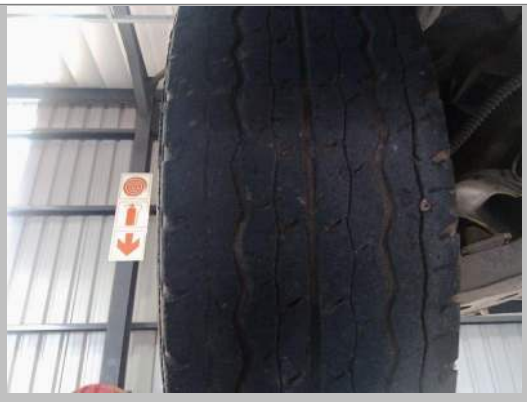
Tyre Rear Right

Size	Load/Speed Index	Manufacture	Model	Type*	Production Date	Tread Depth (mm)
Front Left	195/70R15C	102S	Dunlop	Sp	V	2621	0 mm
Front Right	195/80R15	106S	Michelin	Radial	V	3021	1 mm
Rear Left	195R15C	104S	Sailun	Radial	V	3324	0 mm
Rear Right	215/75R15	100S	Ceat	Radial	V	1718	0 mm
