CONDITION REPORT

Report No:
2017314576
DATE
21/10/2026

Vehicle Type	LIGHT LOAD VEHICLE	Registered Owner	
Manufacturer	HYUNDAI	Registration Number	LP39TCGP
Model	H-100 BAKKIE 2.6 EURO II DECK DSL PU [2020-ON]	Register Number	
		Date Of First Licensing	
VIN	KMFZBX7BLRU077853	Last COR	
Engine Number		License Expiry Date	30/04/2027
Doors	2	Power / Displacement	
Color	WHITE	Paint Finish	C - COMMON
Year Model	2024	Fuel	DIESEL
Km Reading	72,203 KM	Transmission	MANUAL
Cab / Body Type	SINGLE CAB

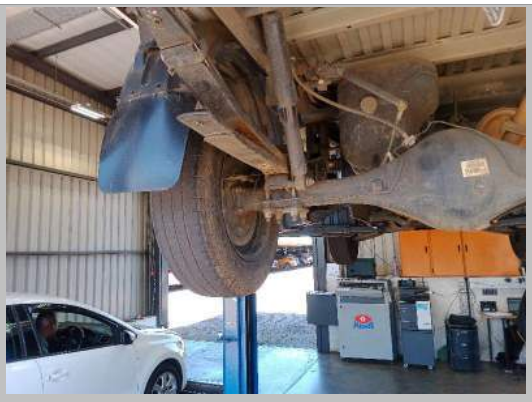
No spare wheel
