CONDITION REPORT

Report No:
2017315212
DATE
21/10/2026

Vehicle Type	LIGHT LOAD VEHICLE	Registered Owner	MFC AUCTION HOUSE
Manufacturer	HYUNDAI	Registration Number	LW72WMGP
Model	H-100	Register Number	
VIN	KMFZBX7BLRU105499	Date Of First Licensing	
Engine Number		Last COR	
Doors	2	License Expiry Date	31/08/2027
Color	WHITE	Power / Displacement	
Year Model		Paint Finish	TWO COAT UNI
Km Reading	44,694 KM	Fuel	DIESEL
Cab / Body Type	SINGLE CAB	Transmission	MANUAL

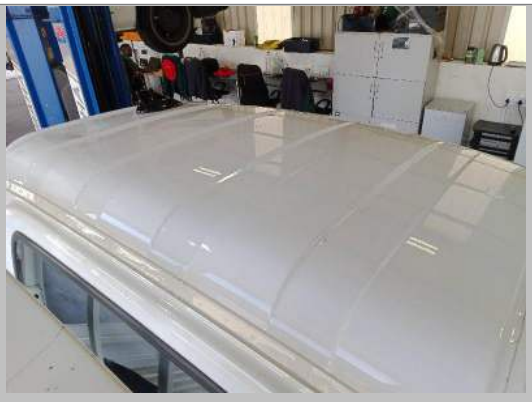
Damage	Repair Way
Engine Oil Leak	Repair
Engine Wiring Defective	Repair
Clutch Pedal Rubber Missing	Replace
Front Bumper Paintwork • Scratched	Repair
Roof Dented	Repair
Load Body Paintwork • Scratched	Repair
Gearbox Oil Leak	Repair
Wheel Spanner Missing	Replace
Deceleration service brake defective	Repair
