CONDITION REPORT

Report No:
2017317189
DATE
27/10/2026

Vehicle Type	PASSENGER VEHICLE	Registered Owner	MFC
Manufacturer	HYUNDAI	Registration Number	JN07ZYGP
Model	ACCENT 1.6 FLUID INFOTAINMENT AT [2018-2019]	Register Number	
		Date Of First Licensing	
VIN	KMHCT41DLKU480774	Last COR	
Engine Number		License Expiry Date	31/08/2026
Doors	4	Power / Displacement	
Color	GREY	Paint Finish	TWO COAT METALLIC
Year Model	2020	Fuel	PETROL
Km Reading	561,578 KM	Transmission	MANUAL
Cab / Body Type	SEDAN

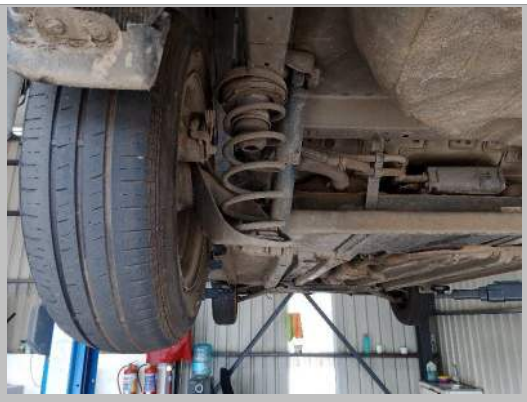
LF TYRE TREAD

Size	Load/Speed Index	Manufacture	Model	Type*	Production Date	Tread Depth (mm)
Front Left	175/70R14	84T	Cachland	Radial	V	1922	0 mm
Front Right	175/70R14	84H	Windforce	Radial	V	1425	0 mm
Rear Left	175/70R14	84H	Windforce	Radial	V	1125	0 mm
Rear Right	175/70R14	84H	Windforce	Radial	V	1425	0 mm

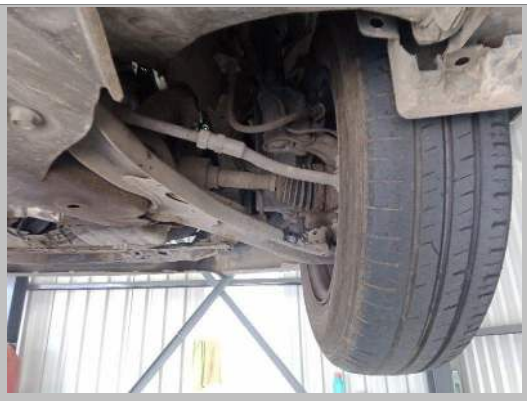
RF TYRE TREAD

Control Arm(s) Front Axle Right Damaged	Replace
Tyre Front Left Worn	Replace
Tyre Front Right Worn	Replace
Tyre Rear Left Worn	Replace
Tyre Rear Right Worn	Replace
Rim Front Left Damaged	Replace
Main Beam Left Damaged	Repair
Main Beam Right Damaged	Repair
Sub Frame Damaged	Replace
Gearbox Oil Leak	Repair
Fuel Tank Damaged	Replace
Radiator Cross Member Damaged	Replace
Engine Performance Insufficient	Repair
Engine Noise Idling / Hunting	Repair
Gear Selections Malfunction	Repair

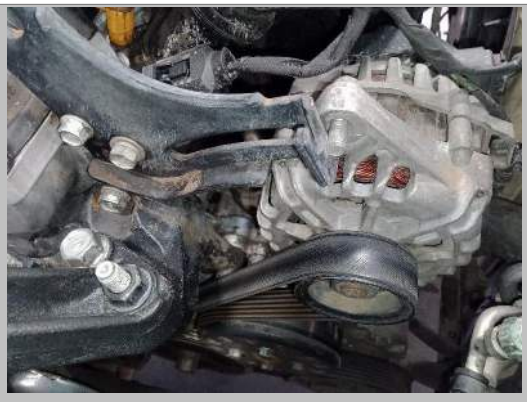
Damage	Repair Way
Engine Wiring Damaged	Replace
Air conditioner pump Defective	Repair
Alternator Defective	Repair
Central Air Vent Damaged	Replace
Radio/CD/USB Missing	Replace
Engine Management Lights Set	Replace
Windscreen Wiper Damaged	Replace
Tail Light Left Damaged	Replace
Tail Light Right Damaged	Replace
Headlight Left Damaged	Replace
Headlight Right Damaged	Replace
Seat Front Left Worn	Repair
Seat Front Right Worn	Repair
Seat Rear Damaged	Repair
Door Panel Front Right Damaged	Replace
Carpet Front Damaged	Replace
Front Bumper Damaged	Repair
Bonnet Damaged	Repair
Front Fender Left Damaged	Repair
Front Fender Right Damaged	Repair
Rear Fender Left Damaged	Repair
Rear Fender Right Damaged	Repair
Door Front Left Damaged	Repair
Door Front Right Damaged	Replace
Door Rear Left Damaged	Repair
Door Rear Right Damaged	Repair
Boot Lid / Hatch door Damaged	Replace
Rear bumper Damaged	Repair
Roof Damaged	Repair
Windscreen Damaged	Replace
