CONDITION REPORT

Report No:
2017316404
DATE
23/10/2026

Vehicle Type	PASSENGER VEHICLE	Registered Owner	MFC AUCTION HOUSE
Manufacturer	HYUNDAI	Registration Number	JR83MDGP
Model	ACCENT 1.6 FLUID INFOTAINMENT AT [2018-2019]	Register Number	
		Date Of First Licensing	
VIN	KMHCT41DLKU481067	Last COR	
Engine Number		License Expiry Date	30/06/2027
Doors	4	Power / Displacement	
Color	GREY	Paint Finish	TWO COAT METALLIC
Year Model	2020	Fuel	PETROL
Km Reading	253,881 KM	Transmission	MANUAL
Cab / Body Type	HATCHBACK

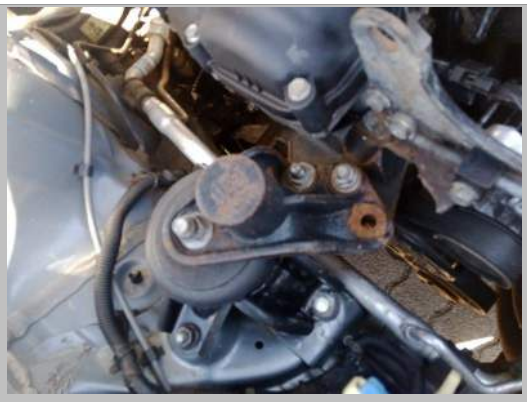
Damage	Repair Way
Engine Oil Leak	Repair
Engine Wiring Damaged	Repair
Engine Management Lights Set	Repair
Tail Light Left Damaged	Replace
Tail Light Right Damaged	Replace
Side Mirror Left Damaged	Replace
Side Mirror Right Damaged	Replace
Front Bumper Damaged	Repair
Bonnet Damaged	Repair
Front Fender Left Damaged	Repair
Front Fender Right Damaged	Repair
Rear Fender Left Damaged	Repair
Rear Fender Right Damaged	Repair
Door Front Left Damaged	Repair
Door Front Right Damaged	Repair
Door Rear Left Damaged	Repair
Door Rear Right Damaged	Repair
Boot Lid / Hatch door Damaged	Repair
Rear bumper Damaged	Repair
Roof Damaged	Repair
Windscreen Damaged	Replace
Tyre Front Left Worn	Replace
Tyre Front Right Worn	Replace
Tyre Rear Left Worn	Replace
Tyre Rear Right Damaged	Replace
Spare Tyre Damaged	Replace
Engine mountings Defective	Repair
Gearbox Oil Leak	Repair
Radiator Cross Member Damaged	Replace
Engine Noise Idling / Hunting	Repair

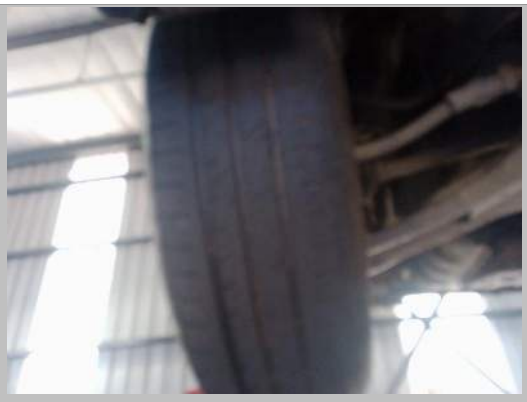
Tyre Rear Left

Size	Load/Speed Index	Manufacture	Model	Type*	Production Date	Tread Depth (mm)
Front Left	175/70R14	84T	Tracmax	Radial	V	3522	0 mm
Front Right	175/70R14	84T	Tracmax	Radial	V	3522	0 mm
Rear Left	175/70R14	84T	Nexen	Radial	V	4021	0 mm
Rear Right	175/65R14	82T	Compasal	Radial	V	0924	1 mm

General Comments: ACCORDING TO THE AGE AND MILEAGE OF THE VEHICLE, NORMAL WEAR AND TEAR MARKS ARE VISIBLE ON THE INTERIOR, EXTERIOR, ELECTRICAL AND MECHANICAL PARTS. 7 DTC'S AT TIME OF TESTING SEE DTC REPORT.Engine Compartment: Battery loose.
Body • Exterior: Minor dents and scratches and stone chips to body panels. Signs of repair work done to body panels. Poor alignment to somebody panels. Repair work done to vehicle below standard.
Tyres and Rims: spare wheel missing. Rear tire sizes do not match.
