CONDITION REPORT

Report No:
2017314685
DATE
20/10/2026

Vehicle Type	PASSENGER VEHICLE	Registered Owner	
Manufacturer	HYUNDAI	Registration Number	FC12SMGP
Model	ACCENT 1.6 FLUID 5-DR AT [2014-2019]	Register Number	
VIN	KMHCU51DMGU260941	Date Of First Licensing	
Engine Number		Last COR	
Doors	5	License Expiry Date	31/01/2027
Color	GREY	Power / Displacement	
Year Model	2016	Paint Finish	M - METALLIC
Km Reading	153,302 KM	Fuel	PETROL
Cab / Body Type	HATCHBACK	Transmission	AUTOMATIC

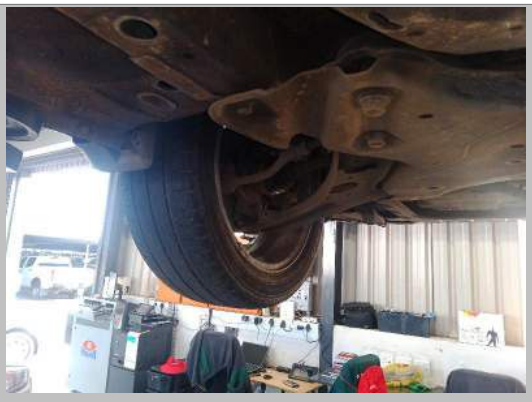
LF TYRE TREAD

Size	Load/Speed Index	Manufacture	Model	Type*	Production Date	Tread Depth (mm)
Front Left	195/50R16	84H	Kumho	Solus	V	3715	3 mm
Front Right	195/50R16	88V	Goodyear	Radial	V	4120	2 mm
Rear Left	195/50R16	88V	Goodyear	Radial	V	4020	3 mm
Rear Right	195/50R16	88V	Goodyear	Radial	V	4120	3 mm
Spare	195/50R16	88V	Goodyear	Radial	V	0000	2 mm

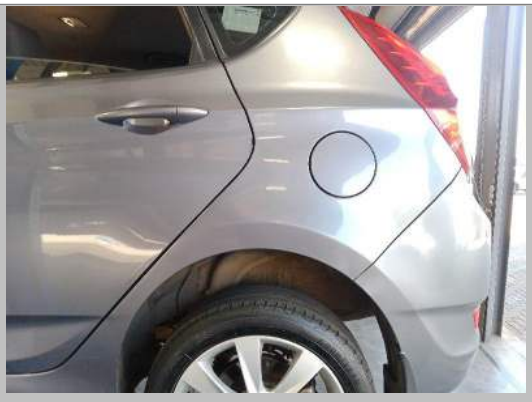
Damage	Repair Way
Water level Insufficient	Repair
Switch Electrical Window Winder front left Malfunction	Repair
Front Bumper Paintwork • Scratched	Repair
Front Fender Left Paintwork • Scratched	Repair
Rear Fender Left Paintwork • Scratched	Repair
Rear Fender Right Paintwork • Scratched	Repair
Door Front Left Paintwork • Scratched	Repair
Door Front Right Dented	Repair
Door Rear Left Paintwork • Scratched	Repair
Rear bumper Paintwork • Scratched	Repair
Windscreen Chipped	Repair
