CONDITION REPORT

Report No:
2017309567
DATE
09/10/2026

Vehicle Type	PASSENGER VEHICLE	Registered Owner	MFC
Manufacturer	HYUNDAI	Registration Number	FXZ390L
Model	TUCSON	Register Number	
VIN	KMHJ2813LJU658315	Date Of First Licensing	
Engine Number		Last COR	
Doors	5	License Expiry Date	
Color	SILVER	Power / Displacement	
Year Model		Paint Finish	M - METALLIC
Km Reading	131,817 KM	Fuel	PETROL
Cab / Body Type	STATION WAGON	Transmission	MANUAL

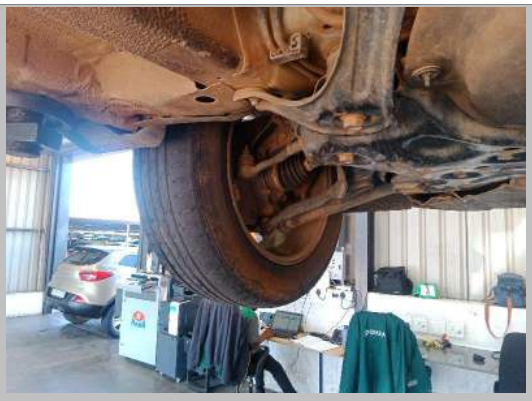
LF TYRE TREAD

Size	Load/Speed Index	Manufacture	Model	Type*	Production Date	Tread Depth (mm)
Front Left	225/60R17	99V	Nexen	N blue	V	3322	2 mm
Front Right	225/60R17	99V	Good trip	Gs-07h/t	V	0623	2 mm
Rear Left	225/60R17	99H	Kumho	Crugen	V	5217	3 mm
Rear Right	225/60R17	99H	Kumho	Crugen	V	5217	2 mm
Spare	255/60R17	99H	Kumho	Crugen	V	0000	3 mm

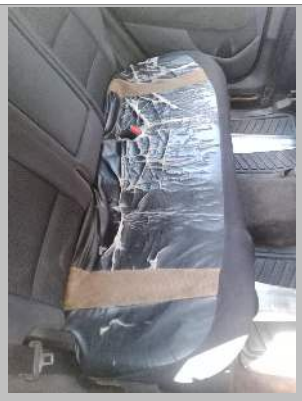
Damage	Repair Way
Seat Front Right Torn / Cut	Repair
Seat Rear Torn / Cut	Repair
Side Mirror Right Paintwork • Scratched	Repair
Front Bumper Paintwork • Scratched	Repair
Bonnet Paintwork • Scratched	Repair
Front Fender Left Paintwork • Scratched	Repair
Front Fender Right Paintwork • Scratched	Repair
Rear Fender Left Paintwork • Scratched	Repair
Rear Fender Right Paintwork • Scratched	Repair
Door Front Left Paintwork • Scratched	Repair
Door Front Right Paintwork • Scratched	Repair
Door Rear Left Paintwork • Discoloured	Repair
Door Rear Right Paintwork • Scratched	Repair
Boot Lid / Hatch door Paintwork • Scratched	Repair
Rear bumper Paintwork • Scratched	Repair
Windscreen Chipped	Repair
Parking Brake Performance Left / Right Difference out of legal range	Repair
Body exterior	Vehicle got some scratches, stone chips and dents
Front tires deferred name brand	Repair
