CONDITION REPORT

Report No:
2017317768
DATE
27/10/2026

Vehicle Type	PASSENGER VEHICLE	Registered Owner	
Manufacturer	KIA	Registration Number	HV35FGGP
Model	PICANTO	Register Number	
VIN	KNAB2511LKT373931	Date Of First Licensing	
Engine Number		Last COR	
Doors	5	License Expiry Date	
Color	RED	Power / Displacement	
Year Model		Paint Finish	C - COMMON
Km Reading	120,332 KM	Fuel	PETROL
Cab / Body Type	HATCHBACK	Transmission	MANUAL

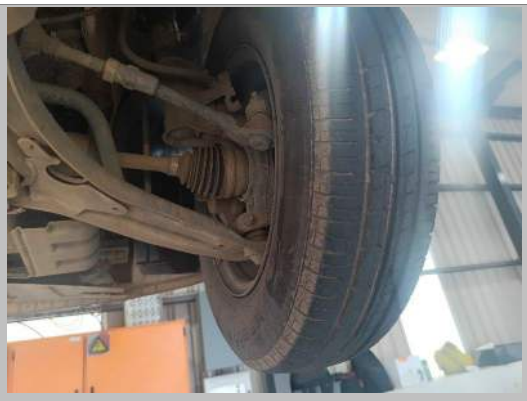
LR TYRE TREAD

Size	Load/Speed Index	Manufacture	Model	Type*	Production Date	Tread Depth (mm)
Front Left	155/80R13	79T	ADAMAS H/P	POWERTRAC	V	2224	3 mm
Front Right	155/80R13	79T	ADAMAS H/P	POWERTRAC	V	2224	3 mm
Rear Left	T115/70D15	90M	Maxis	temporary	V	2818	1 mm
Rear Right	155/80R13	79T	ANNAITE	AN600	V	1725	4 mm
Spare	155/80R13	79T	SUMITOMO	HTR T5	V	0916	1 mm

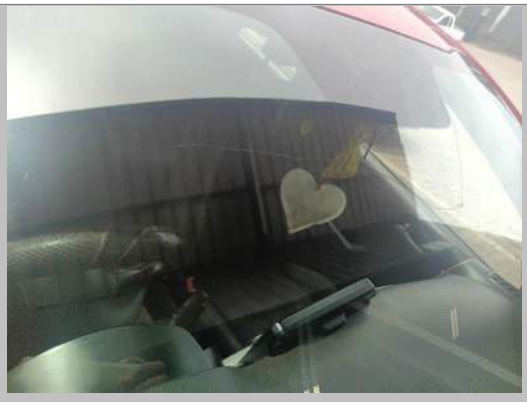
Door Front Right Poor Alignment	Repair
Door Rear Left Dented	Repair
Door Rear Right Paintwork • Scratched	Repair
Boot Lid / Hatch door Damaged	Repair
Rear bumper Damaged	Repair
Rear Bumper / Mounting points Damaged	Replace
Sill Panel Left Damaged	Repair
Sill Panel Right Damaged	Repair
Windscreen Cracked	Replace
Parking Brake Performance Insufficient	Repair
Tyre Rear Left Worn	Replace
Spare Tyre Torn / Cut	Replace
Rim Rear Left Dented	Repair
Silencer Damaged	Replace
Belly plates Damaged	Replace
Radiator Cradle Damaged	Replace
BODY EXTERIOR	excessive dents scratches stone chips on body
LICENSE DISC	Not available
Rear Bumper stiffener	damaged
BODY EXTERIOR	Signs of impact damage to rear of vehicle
Boot light and safety belt	illuminated

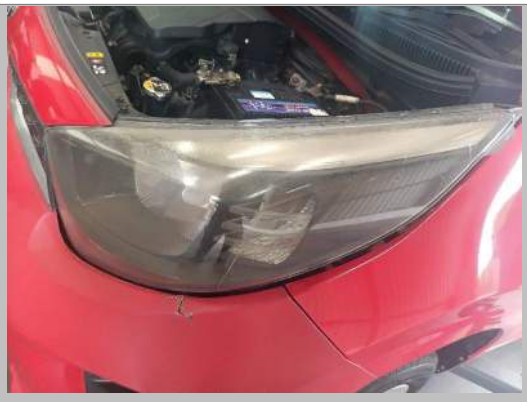
Damage	Repair Way
Center Console / Cubbyhole + Lid Damaged	Repair
Windscreen Wiper Damaged	Replace
Air Conditioner Defective	Repair
Park Light Rear Right Damaged	Replace
Tail Light Right Damaged	Replace
Headlight Left Damaged	Replace
Headlight Right Defective	Repair
Seat Front Left Torn / Cut	Repair
Seat Front Right Excessive Wear & Tear	Repair
Seat Belt Front Right Defective	Repair
Door Sealing Rubber Front Right Worn	Replace
Door Sealing Rubber Rear Right Torn / Cut	Replace
Parcel Tray Damaged	Replace
Channel / Roof Gutter Left Paintwork • Flaking	Repair
Channel / Roof Gutter Right Paintwork • Flaking	Repair
Side Mirror Left Damaged	Replace
Front Bumper Damaged	Repair
Bonnet Discoloured	Repair
A • Pillar Left Dented	Repair
A • Pillar Right Dented	Repair
Front Fender Left Poor Alignment	Repair
Front Fender Right Paintwork • Scratched	Repair
Rear Fender Left Damaged	Repair
Rear Fender Right Damaged	Repair
Door Front Left Paintwork • Scratched	Repair
