CONDITION REPORT

Report No:
2017314594
DATE
20/10/2026

Vehicle Type	PASSENGER VEHICLE	Registered Owner	
Manufacturer	KIA	Registration Number	KJJ616NW
Model	PICANTO	Register Number	
VIN	KNAB2511LLT595301	Date Of First Licensing	
Engine Number		Last COR	
Doors	5	License Expiry Date	31/07/2027
Color	BLUE	Power / Displacement	
Year Model		Paint Finish	M - METALLIC
Km Reading	158,894 KM	Fuel	PETROL
Cab / Body Type	HATCHBACK	Transmission	MANUAL

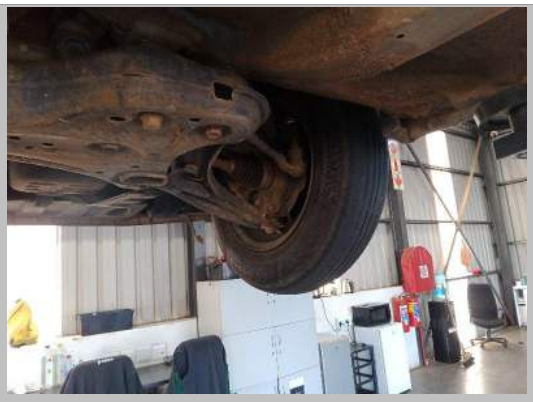
LF TYRE TREAD

Size	Load/Speed Index	Manufacture	Model	Type*	Production Date	Tread Depth (mm)
Front Left	155/80R13	79S	Timax	Tm568	V	1425	0 mm
Front Right	155/80R13	79S	Timax	Tm568	V	0825	0 mm
Rear Left	155/80R13	79T	Sumitomo	Bc100	V	4521	0 mm
Rear Right	T115/70D15	90M	Maxxis	Temporary	V	2919	2 mm
Spare	155/80R13	79T	Sumitomo	Bc100	V	0000	3 mm
