CONDITION REPORT

Report No:
2017305262
DATE
30/09/2026

Vehicle Type	PASSENGER VEHICLE	Registered Owner	MFC AUCTION HOUSE
Manufacturer	KIA	Registration Number	LB23PFGP
Model	PICANTO	Register Number	
VIN	KNAB2511LPT052387	Date Of First Licensing	
Engine Number		Last COR	
Doors	5	License Expiry Date	31/01/2027
Color	SILVER	Power / Displacement	
Year Model		Paint Finish	M - METALLIC
Km Reading	242,710 KM	Fuel	PETROL
Cab / Body Type	HATCHBACK	Transmission	MANUAL

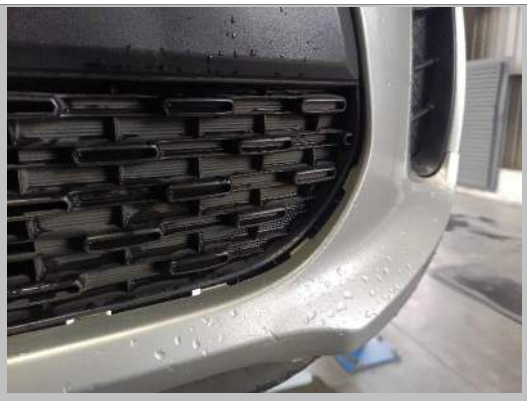
Front Bumper
