# CONDITION REPORT

**Report No:**
**2017318023**
**DATE**
**27/10/2026**

| Manufacturer | KIA | Registration Number | MK59LGGP |
| VIN | KNAB2511LST373719 | Date Of First Licensing | |

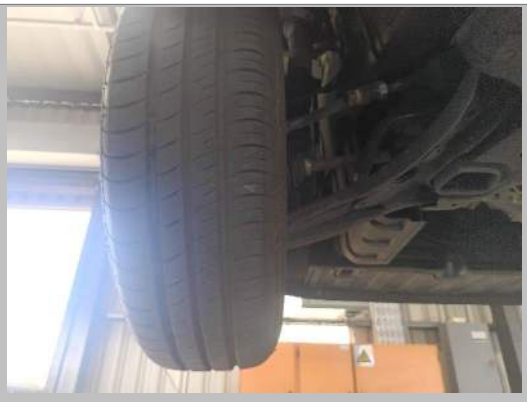
LF TYRE TREAD

| | Size | Load/Speed Index | Manufacture | Model | Type* | Production Date | Tread Depth (mm) |
|---|---|---|---|---|---|---|---|
| **Front Left** | 175/65R14 | 86T | KHUMO | ECOWING | V | 1125 | 5 mm |

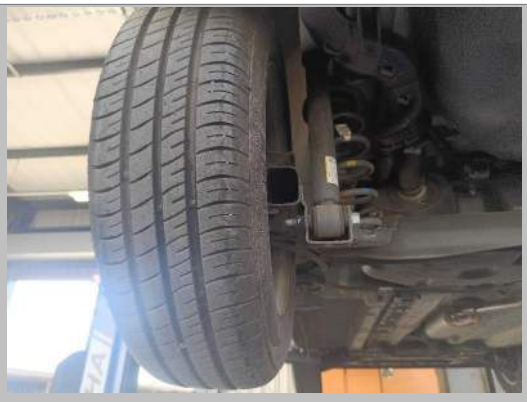
LR TYRE TREAD

| | Size | Load/Speed Index | Manufacture | Model | Type* | Production Date | Tread Depth (mm) |
|---|---|---|---|---|---|---|---|
| **Rear Left** | 175/65R14 | 86T | KHUMO | ECOWING | V | 1125 | 5 mm |
