# CONDITION REPORT

**Report No:**
**2017311602**
**DATE**
**13/10/2026**

| Manufacturer | KIA | Registration Number | FW49KJGP |
| Model | RIO | Register Number | |

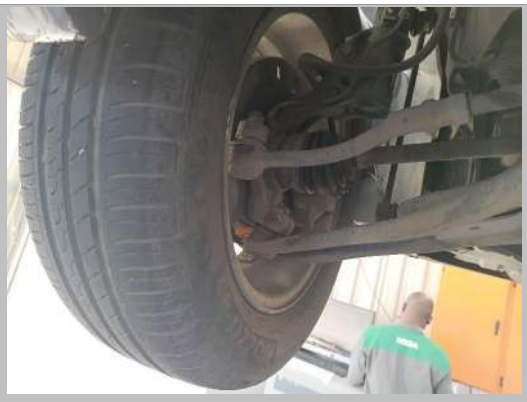
LF TYRE TREAD

| Damage | Repair Way |
|---|---|
| Tyre Front Left Excessive Wear & Tear | Replace |

| | Size | Load/Speed Index | Manufacture | Model | Type* | Production Date | Tread Depth (mm) |
|---|---|---|---|---|---|---|---|
| **Front Left** | 185/65R15 | 88H | Duraturn | Mozzo | V | 0000 | 2 mm |

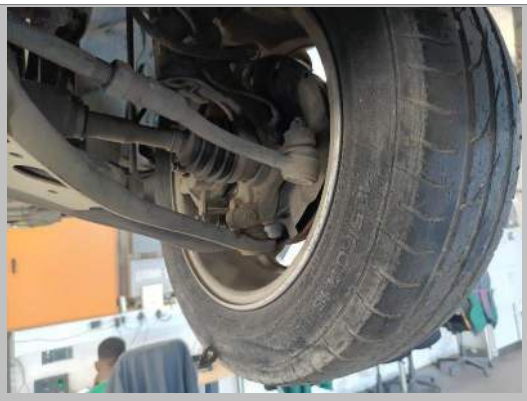
RF TYRE TREAD

| Damage | Repair Way |
|---|---|
| Tyre Front Right Damaged | Replace |

| | Size | Load/Speed Index | Manufacture | Model | Type* | Production Date | Tread Depth (mm) |
|---|---|---|---|---|---|---|---|
| **Front Right** | 185/60R15 | 84H | Continental | Contact | V | 4319 | 1 mm |

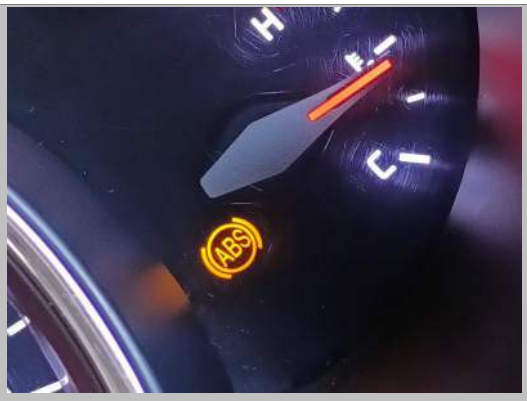
| Damage | Repair Way |
|---|---|
| Warning lights illuminated | Repair |

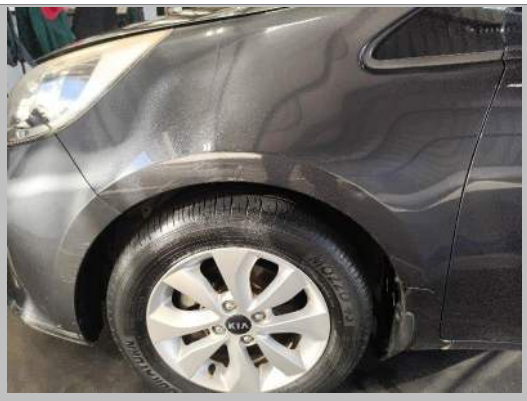
| Damage | Repair Way |
|---|---|
| Front Fender Left Paintwork • Scratched | Repair |

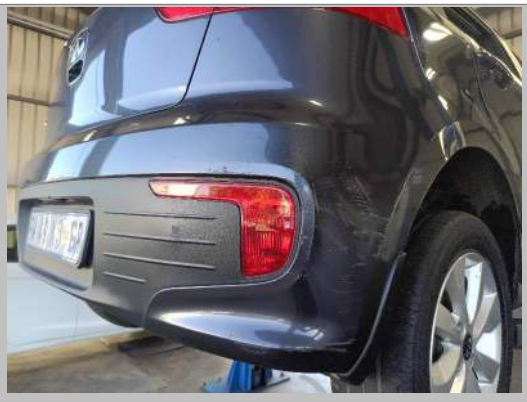
| Damage | Repair Way |
|---|---|
| Rear bumper Paintwork • Scratched | Repair |
