CONDITION REPORT

Report No:
2017306875
DATE
02/10/2026

Vehicle Type	LIGHT LOAD VEHICLE	Registered Owner	MFC
Manufacturer	KIA	Registration Number	KP46GYGP
Model	K2700	Register Number	
VIN	KNCSHX71LN7586476	Date Of First Licensing	
Engine Number		Last COR	
Doors	2	License Expiry Date	31/07/2027
Color	WHITE	Power / Displacement	
Year Model		Paint Finish	TWO COAT UNI
Km Reading	130,390 KM	Fuel	DIESEL
Cab / Body Type	SINGLE CAB	Transmission	MANUAL

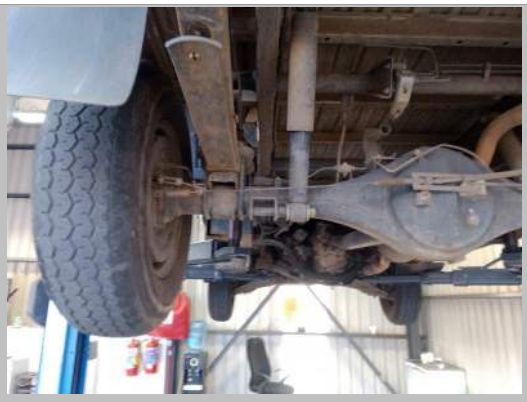
LF TYRE TREAD

Size	Load/Speed Index	Manufacture	Model	Type*	Production Date	Tread Depth (mm)
Front Left	195R14LT	103R	Timax	Radial	V	3025	0 mm
Front Right	195R14LT	103R	Timax	Radial	V	3025	0 mm
Rear Left	195R14C	104R	Dunlop	Sp	V	1525	0 mm
Rear Right	195R14C	104R	Dunlop	Sp	V	1425	0 mm

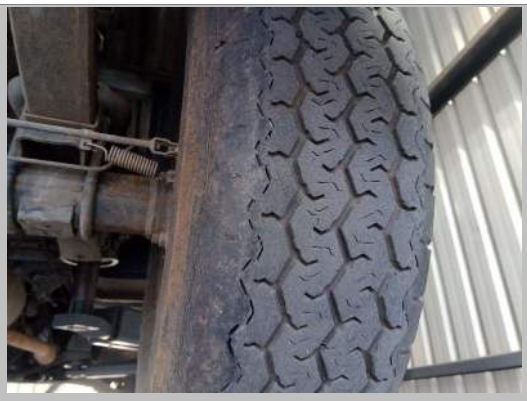
Damage	Repair Way
Engine Oil Leak	Repair
Hoses Damaged	Repair
Central Air Vent Damaged	Replace
Center Console / Cubbyhole + Lid Damaged	Repair
Tail Light Right Damaged	Replace
Number Plate Light Right Damaged	Replace
Headlight Left Damaged	Replace
Headlight Right Damaged	Repair
Seat Front Right Damaged	Repair
Number Plate Rear Damaged	Repair
Front Bumper Damaged	Repair
Bonnet Damaged	Repair
Front Fender Right Damaged	Replace
Door Front Left Damaged	Repair
Door Front Right Damaged	Repair
Tailgate Damaged	Repair
Rear bumper Damaged	Repair
Load Body Damaged	Repair
Windscreen Damaged	Replace
Service Brake Performance Front Axle Left / Right Difference out of legal range	Repair
Tyre Front Left Worn	Replace
Tyre Front Right Worn	Replace
Tyre Rear Left Worn	Replace
Tyre Rear Right Worn	Replace
Gearbox Oil Leak	Repair
