CONDITION REPORT

Report No:
2017315657
DATE
22/10/2026

Vehicle Type	PASSENGER VEHICLE	Registered Owner	
Manufacturer	HAVAL	Registration Number	JM89TYGP
Model	H1	Register Number	
VIN	LGWED2A3XLE621257	Date Of First Licensing	
Engine Number		Last COR	
Doors	5	License Expiry Date	31/07/2027
Color	SILVER	Power / Displacement	
Year Model		Paint Finish	TWO COAT METALLIC
Km Reading	137,078 KM	Fuel	PETROL
Cab / Body Type	STATION WAGON	Transmission	MANUAL

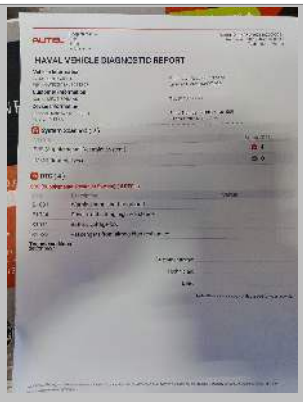
Diagnostic.

No	System	Code	Description	Status
1	SRS	B1091	WARNING LAMP SHORTS TO GROUND

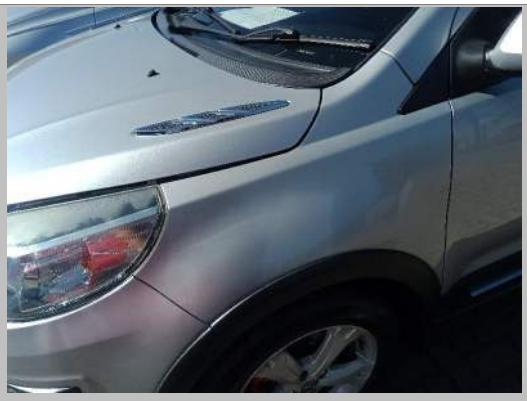
Damage	Repair Way
Center Console / Cubbyhole + Lid Damaged	Repair
Engine Management Lights Set	Repair
Windscreen Wiper Damaged	Replace
Seat Front Right Damaged	Repair
Front Bumper Damaged	Repair
Bonnet Damaged	Repair
Front Fender Left Damaged	Repair
Door Front Left Damaged	Repair
Door Rear Left Damaged	Repair
Door Rear Right Damaged	Repair
Boot Lid / Hatch door Damaged	Repair
Rear bumper Damaged	Repair
Windscreen Damaged	Replace
