CONDITION REPORT

Report No:
2017307849
DATE
06/10/2026

Vehicle Type	PASSENGER VEHICLE	Registered Owner	MFC AUCTION HOUSE
Manufacturer	HAVAL	Registration Number	LD78CKGP
Model	H2 1.5 CITY [2020-2022]	Register Number	
VIN	LGWEE4A45MH907261	Date Of First Licensing	
Engine Number		Last COR	
Doors	5	License Expiry Date	31/07/2026
Color	WHITE	Power / Displacement	
Year Model	2020	Paint Finish	TWO COAT UNI
Km Reading	109,274 KM	Fuel	PETROL
Cab / Body Type	STATION WAGON	Transmission	MANUAL

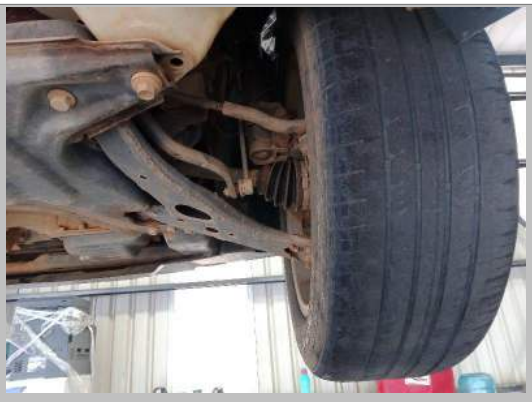
LF TYRE TREAD

Size	Load/Speed Index	Manufacture	Model	Type*	Production Date	Tread Depth (mm)
Front Left	235/55 R18	104V	Rapid	Ecosaver	V	1121	1 mm
Front Right	235/55 R18	100H	Kumho	Solus	V	4819	1 mm
Rear Left	235/55 R18	100H	Kumho	Solue	V	4720	2 mm
Rear Right	235/55 R18	100H	Kumho	Solus	V	4720	4 mm
Spare	T155/85 R18	115M	Chaoyang	Temporary	V	3720	0 mm

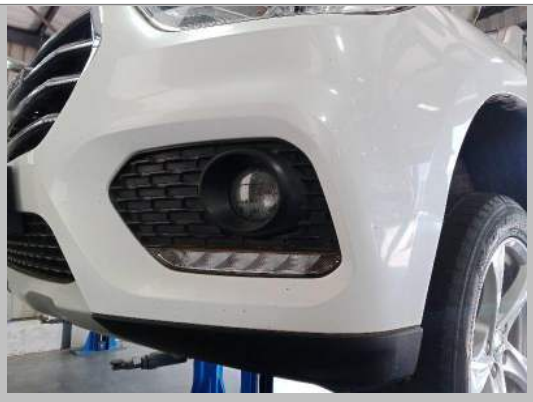
Damage	Repair Way
Hazard Lights Malfunction	Repair
Seat Front Right Damaged	Repair
Front Bumper Paintwork • Scratched	Repair
Bonnet Damaged	Repair
B • Pillar Left Paintwork • Scratched	Repair
Front Fender Left Damaged	Repair
Front Fender Right Damaged	Repair
Door Front Right Dented	Repair
Door Rear Left Residual Traces of Repair	Repair
Door Rear Right Residual Traces of Repair	Repair
Rear bumper Damaged	Repair
Roof Damaged	Repair
Windscreen Cracked	Replace
Shock Absorber Rear Left Sweat	Replace
Shock Absorber Rear Right Sweat	Replace
Tyre Front Left Torn / Cut	Replace
Engine Noise Excessive	Repair
Deceleration parking brake defective	Repair
Warning light illuminated on dashboard	Repair
