CONDITION REPORT

Report No:
2017315737
DATE
22/10/2026

Vehicle Type	PASSENGER VEHICLE	Registered Owner	
Manufacturer	HAVAL	Registration Number	HT40VVGP
Model	H2	Register Number	
VIN	LGWEE4A46KH901241	Date Of First Licensing	
Engine Number		Last COR	
Doors	5	License Expiry Date	30/06/2026
Color	BROWN	Power / Displacement	
Year Model		Paint Finish	TWO COAT METALLIC
Km Reading	135,508 KM	Fuel	PETROL
Cab / Body Type	STATION WAGON	Transmission	AUTOMATIC

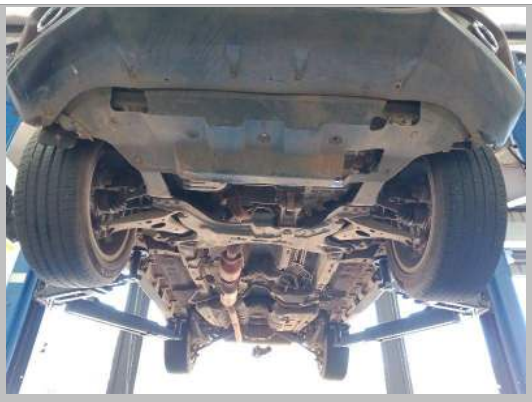
ENGINE 1

Damage	Repair Way
Engine Oil Leak	Repair
Indicator Light Front Right Damaged	Replace
Seat Front Left Damaged	Repair
Seat Front Right Damaged	Repair
Hood Lining Defective	Repair
Door Panel Rear Right Torn / Cut	Repair
Door Sealing Rubber Front Left Damaged	Replace
Door Sealing Rubber Front Right Damaged	Replace
Door Sealing Rubber Rear Left Damaged	Replace
Door Sealing Rubber Rear Right Damaged	Replace
Side Mirror Right Paintwork • Scratched	Repair
Front Bumper Damaged	Repair
Bonnet Dented	Repair
Bonnet slam plate (Shock tower/ Inner tray) Defective	Repair
C • Pillar Right Dented	Repair
Front Fender Left Dented	Repair
Front Fender Right Damaged	Repair
Rear Fender Left Damaged	Repair
Rear Fender Right Residual Traces of Repair	Repair
Door Front Left Damaged	Repair
Door Front Right Paintwork • Scratched	Repair
Door Rear Left Damaged	Repair
Door Rear Right Damaged	Repair
Boot Lid / Hatch door Dented	Repair
Boot Lid / Hatch Door Rubbers Defective	Repair

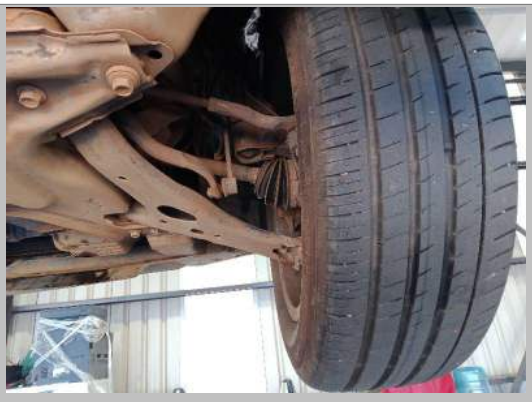
Rear chassis

Rear bumper Damaged	Repair
Roof Dented	Repair
Windscreen Chipped	Repair
Steering Rack Boot Right Damaged	Replace
Control Arm(s) Front Rear Left Damaged	Replace
Chassis Damaged	Repair
CV Joint(s) Boot(s) Front Right (inner/outer) Defective	Replace
Radiator Cradle Dented	Repair
Engine Noise Excessive	Repair
Jack Missing	Replace
Triangle Missing	Replace
Warning lights illuminated on dashboard	Repair
